February 28, 2020

**Re: Seawall Inspection Report for Capri Isle Garden Apts  
280 126<sup>th</sup> Ave E, Treasure Island, FL 33706**

**Mr. Hoyt Koon, Capri Isle Garden Apartments****RE: Seawall Inspection Report – Capri Isle Garden Apts, 280 126<sup>th</sup> Ave E, Treasure Island, FL****February 28, 2020****Page 2**

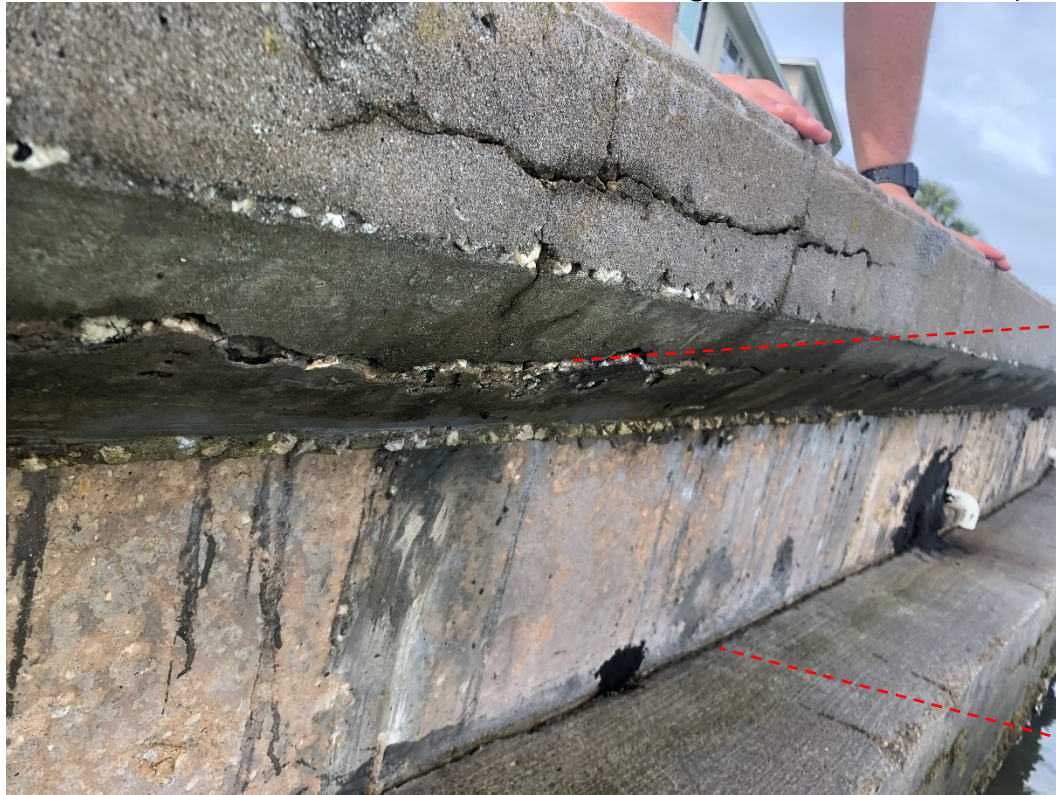
Photo #1- View of the Face and Beveled Edge of the Seawall Cap.

Longitudinal  
Cracking in Cap

Gap Developing  
Between Vertical  
Wall & Stress Beam

1. Clean and seal all cracking in the seawall cap, vertical slabs and stress beam with epoxy or hydraulic cement.
2. All voids behind the seawall should be filled with crushed shell or pea gravel as needed (perhaps more than once) to fill in the existing voids behind the seawall, allowing for drainage, but aid in trapping the sand particles.
3. The gap between the stress beam and vertical wall should be cleaned and sealed with hydraulic cement (175 linear feet)
4. All the secondary anchors, washers and nuts need to be chipped, wire brushed and liberally tarred.
5. Gap between stress beam and vertical wall should be monitored for potential future movement of wall.

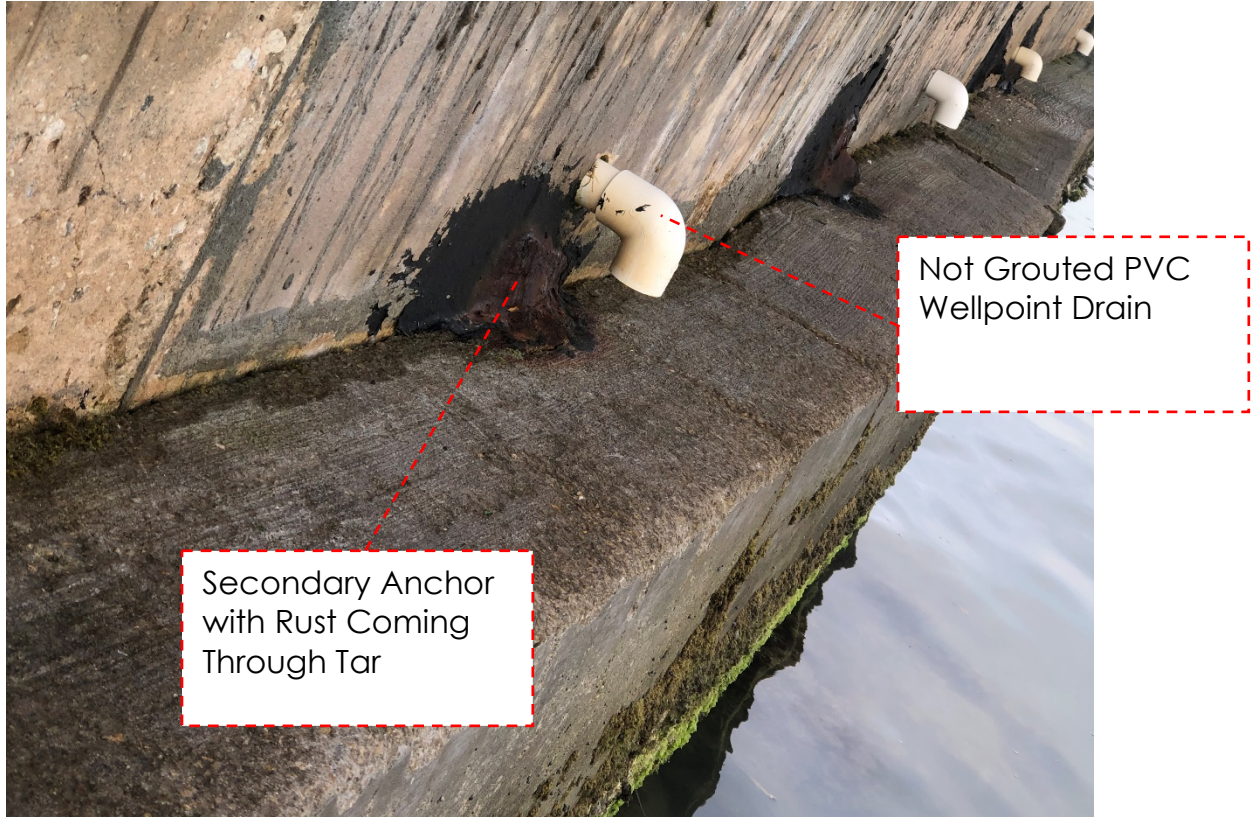
Photo #2 - View of Wellpoint Drain and Secondary Anchor.

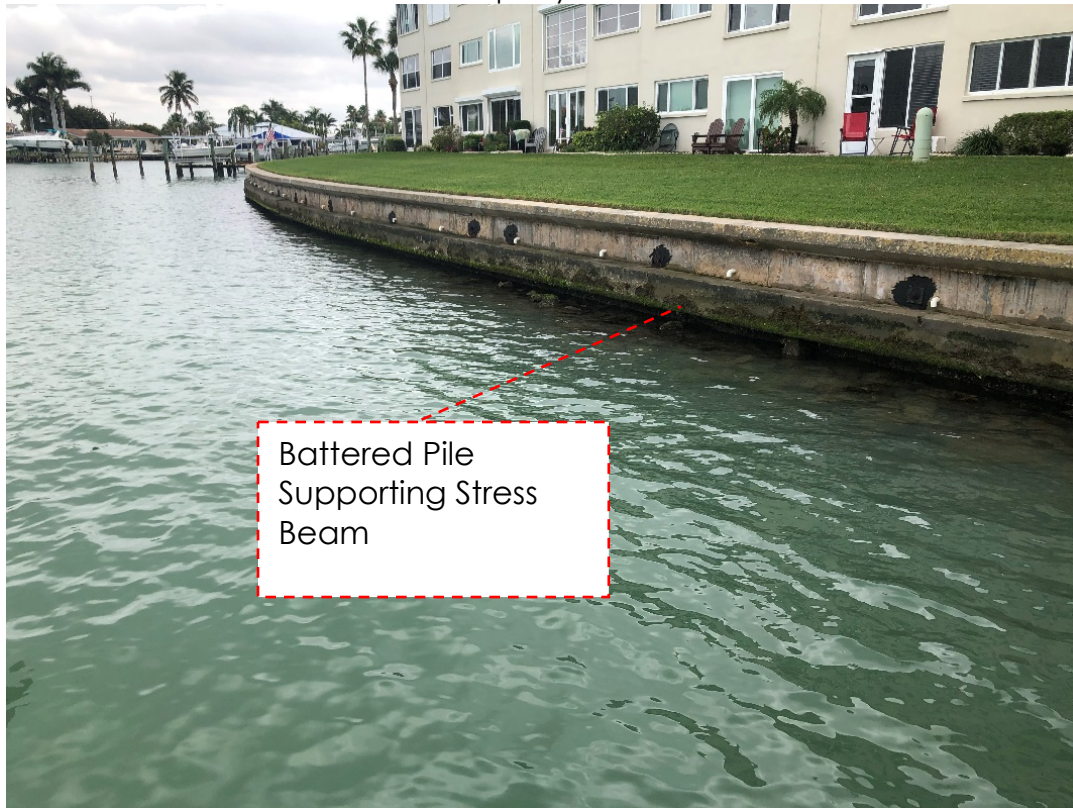
Photo #3- View of East Side of Property.

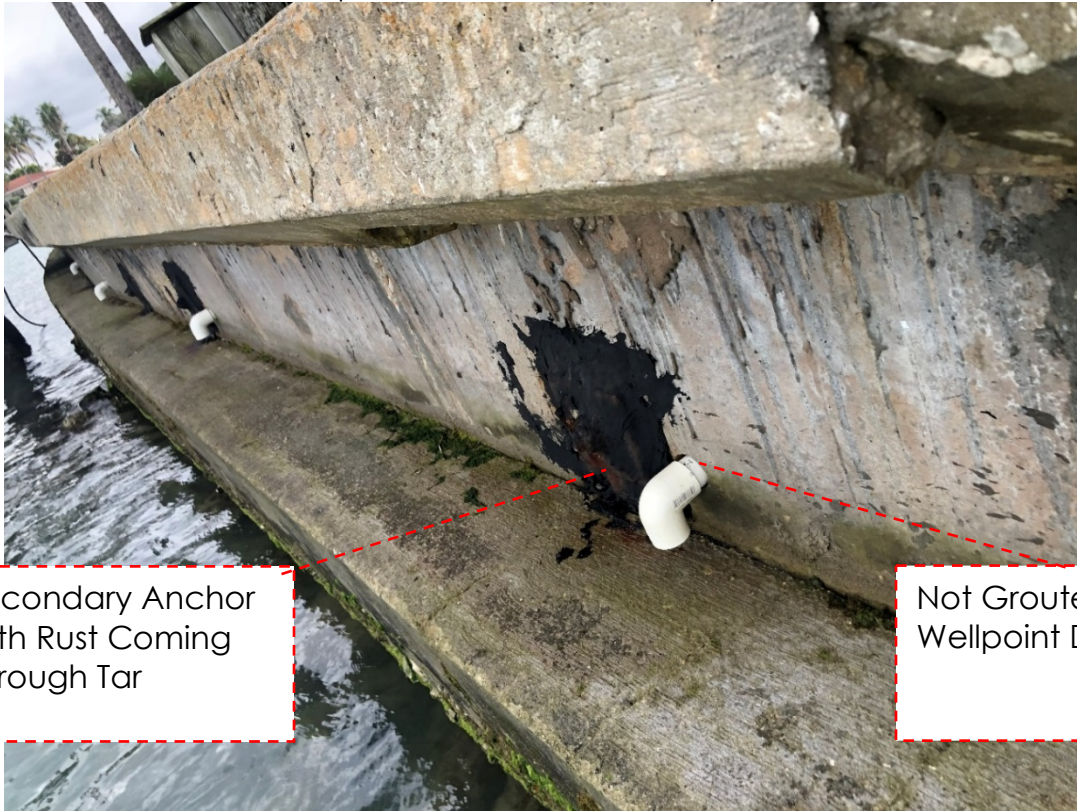
Photo #4- View of Wellpoint Drain and Secondary Anchor.

Secondary Anchor  
with Rust Coming  
Through Tar

Not Grouted PVC  
Wellpoint Drain

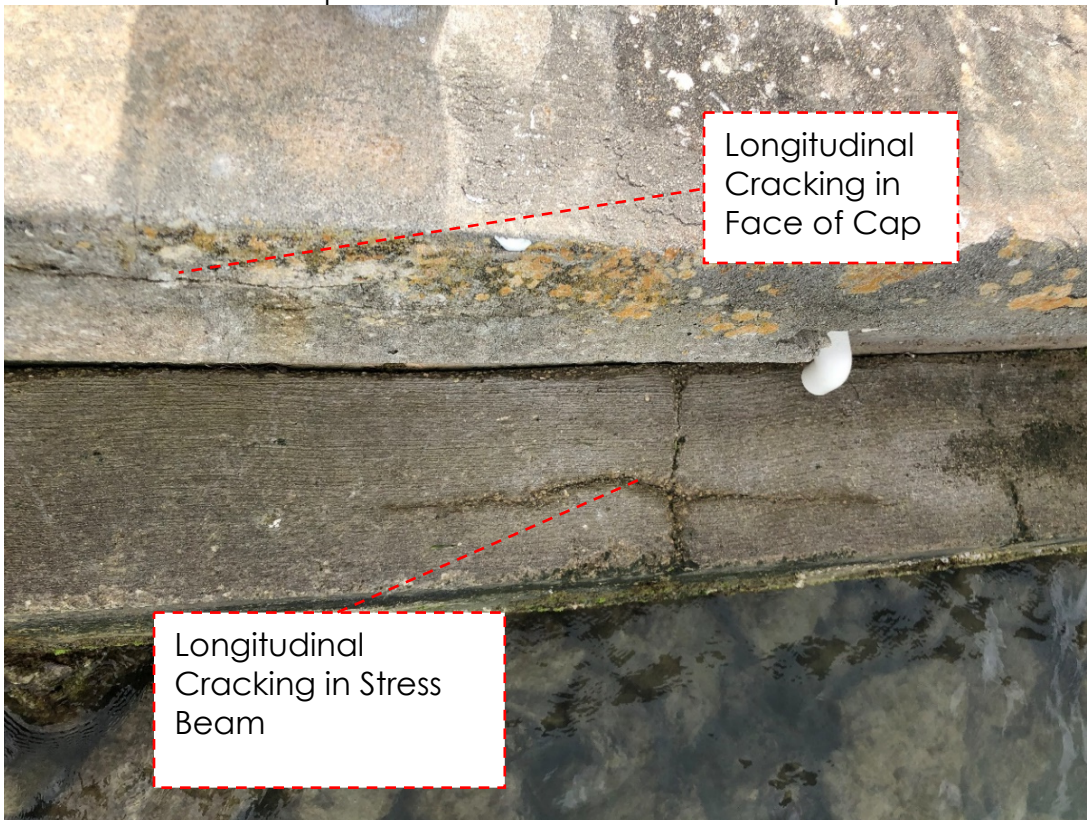
Photo #5 – View of Top of Stress Beam and Face of Cap.

Longitudinal  
Cracking in  
Face of Cap

Longitudinal  
Cracking in Stress  
Beam

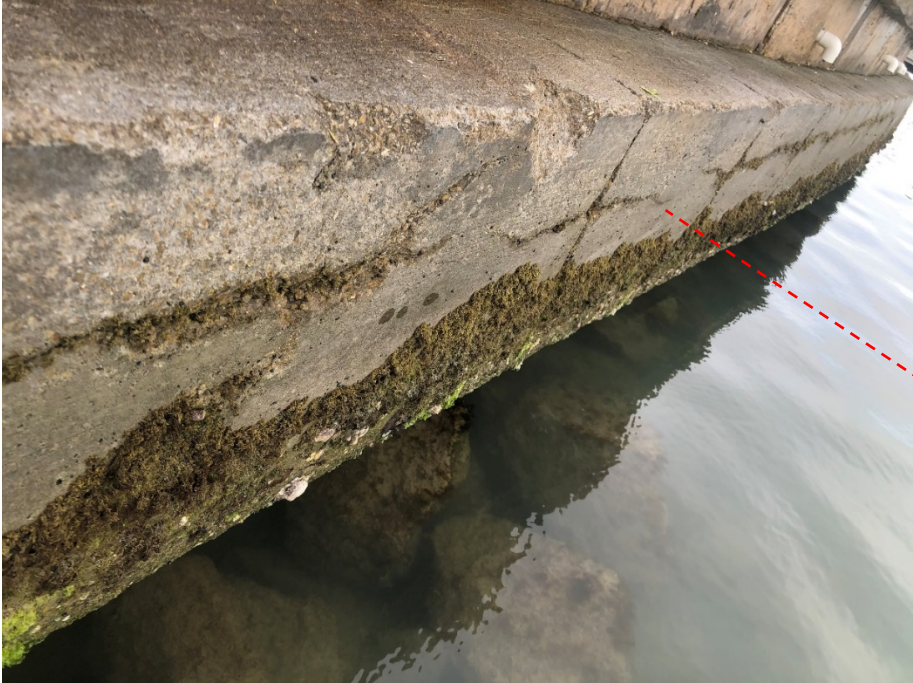
Photo #6 – View of Face of Stress Beam.

Longitudinal  
Cracking in Face  
of Stress Beam

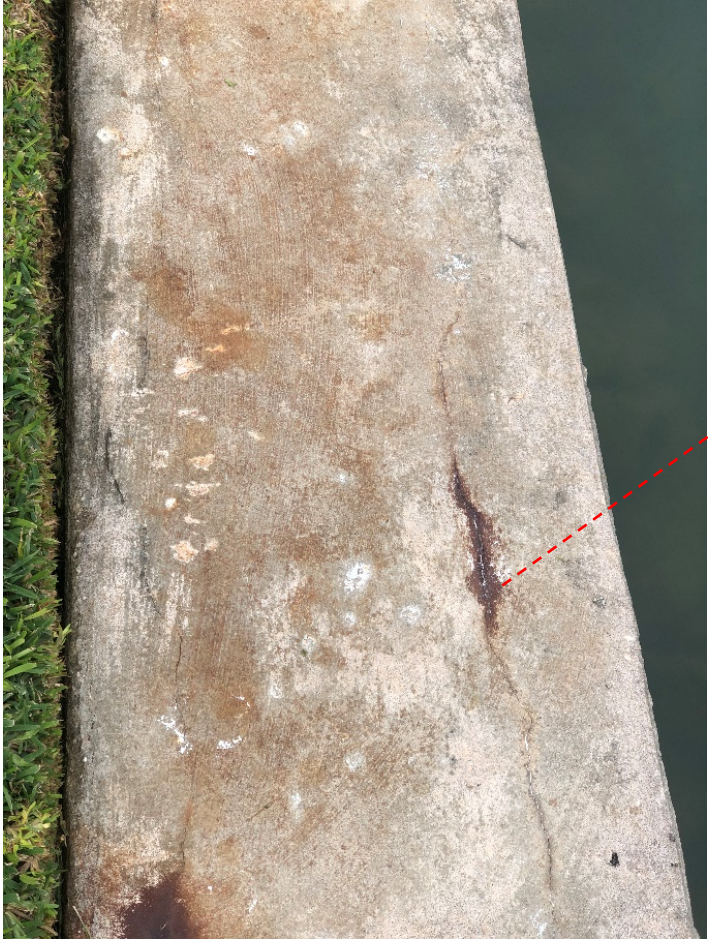
Photo #7 – View of Top of Cap.

Longitudinal  
Cracking in  
Face of Cap
