November 9, 2023

THIS MILESTONE PHASE 1 INSPECTION REPORT WAS PRODUCED FOR CAPRI ISLE GARDEN APARTMENTS NO. 2 CONDOMINIUM ASSOCIATION, INC. LOCATED AT 280 126TH AVE, TREASURE ISLAND, FL 33706.

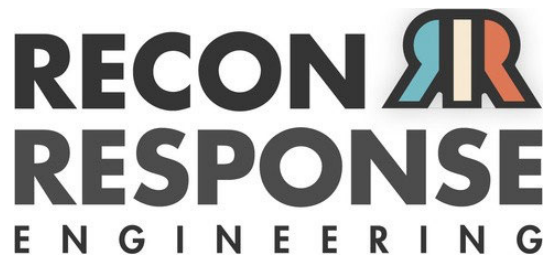
As stated in SB4D, if we find no signs of substantial structural deterioration to the building components under visual examination, then a Phase 2 inspection is not required. If, however, any substantial deterioration is identified during the Phase 1 inspection, then a Phase 2 inspection must be performed.

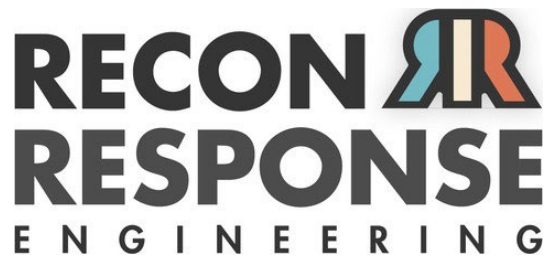
## **APPLICABLE DEFINITIONS FROM THE FLORIDA BUILDING CODE**

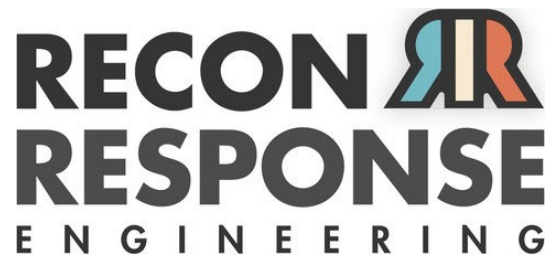
### **DOCUMENTS REVIEWED**

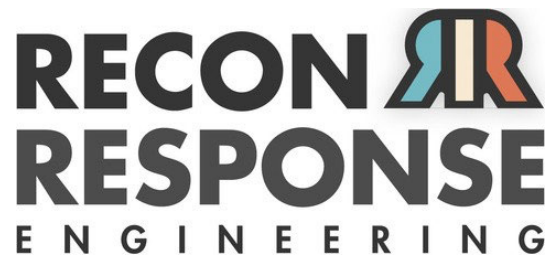
**Required Item 6 of 6:** *Identify and describe any items requiring further inspection.*

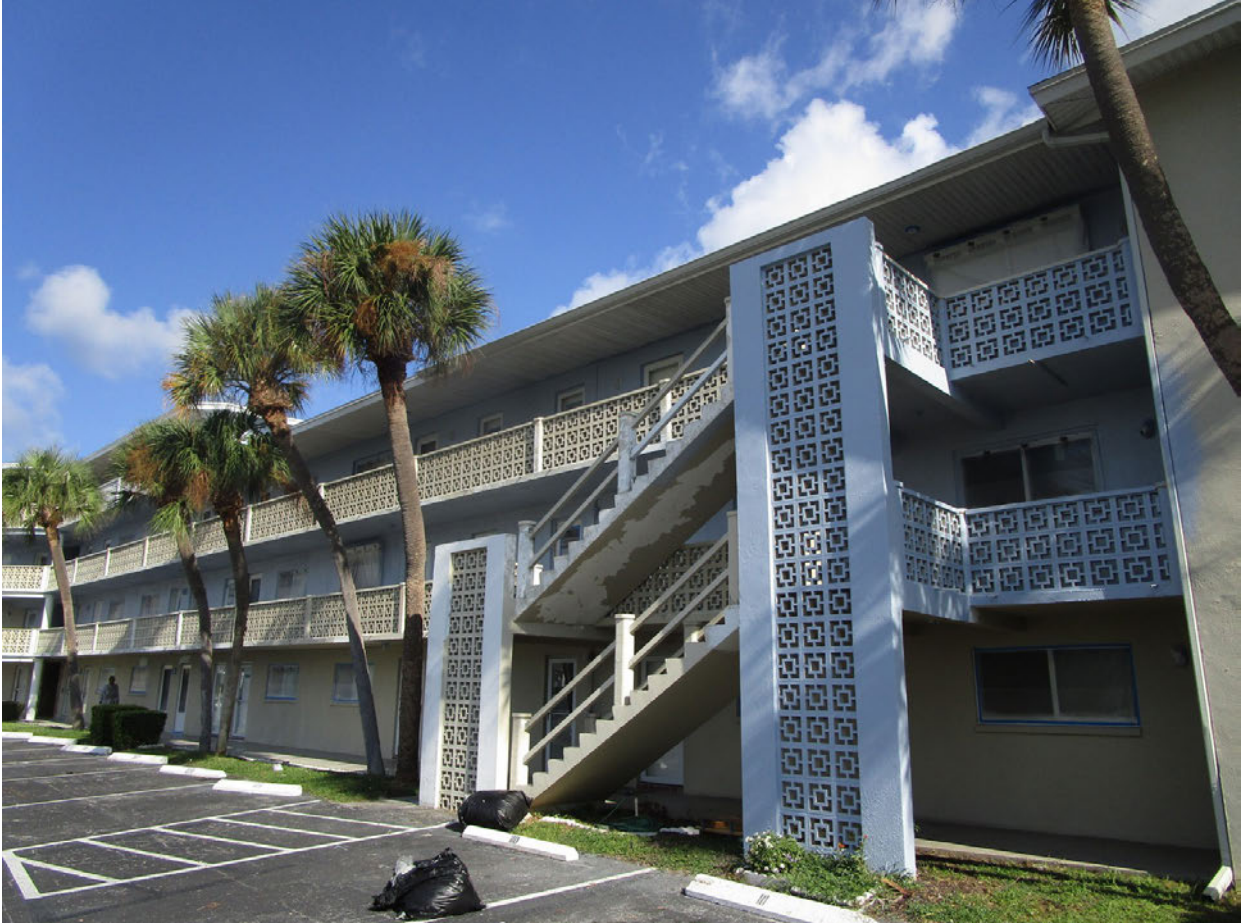
**Exterior Elevation View. South Side**

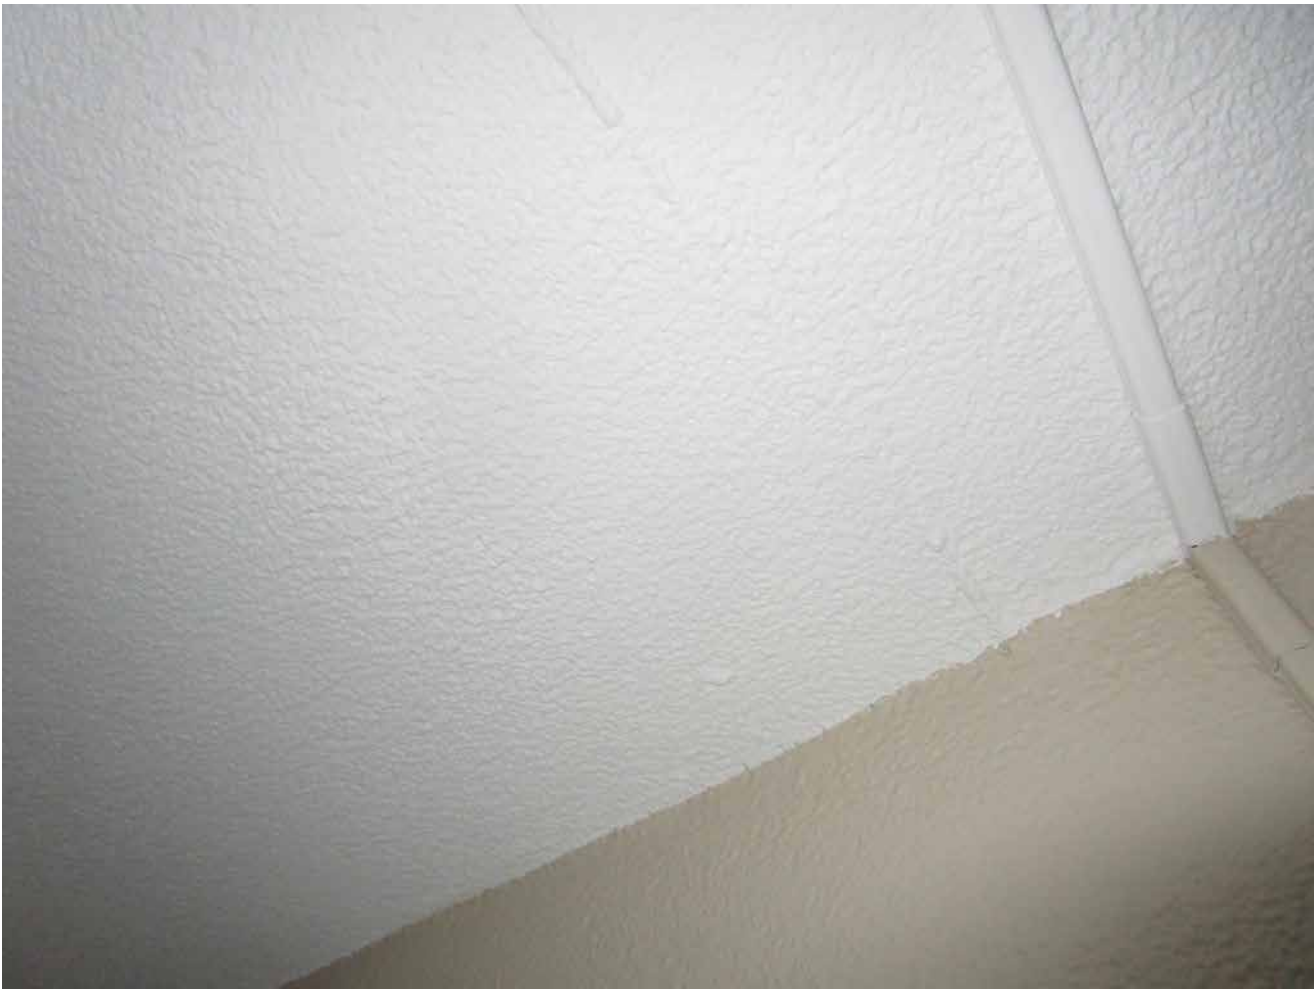
*Capri Isle Garden Apartments No. 2. Unit 105. Minor cracking in interior ceilings observed, which is typical for this construction. This is not a structural issue and no action is required.*

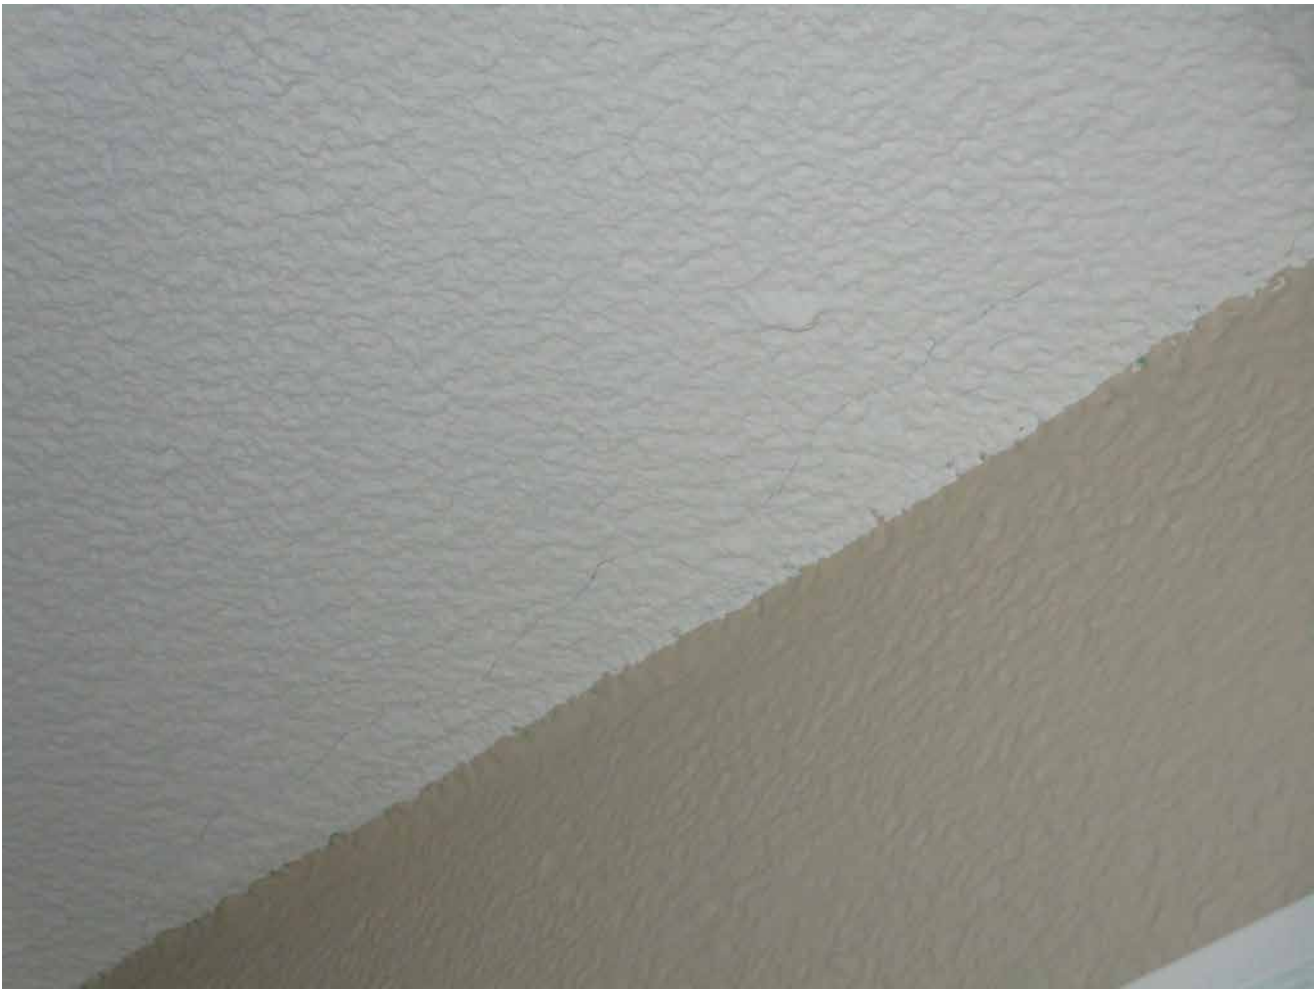
*Capri Isle Garden Apartments No. 2. Unit 105. Minor cracking in interior ceilings observed, which is typical for this construction. This is not a structural issue and no action is required.*

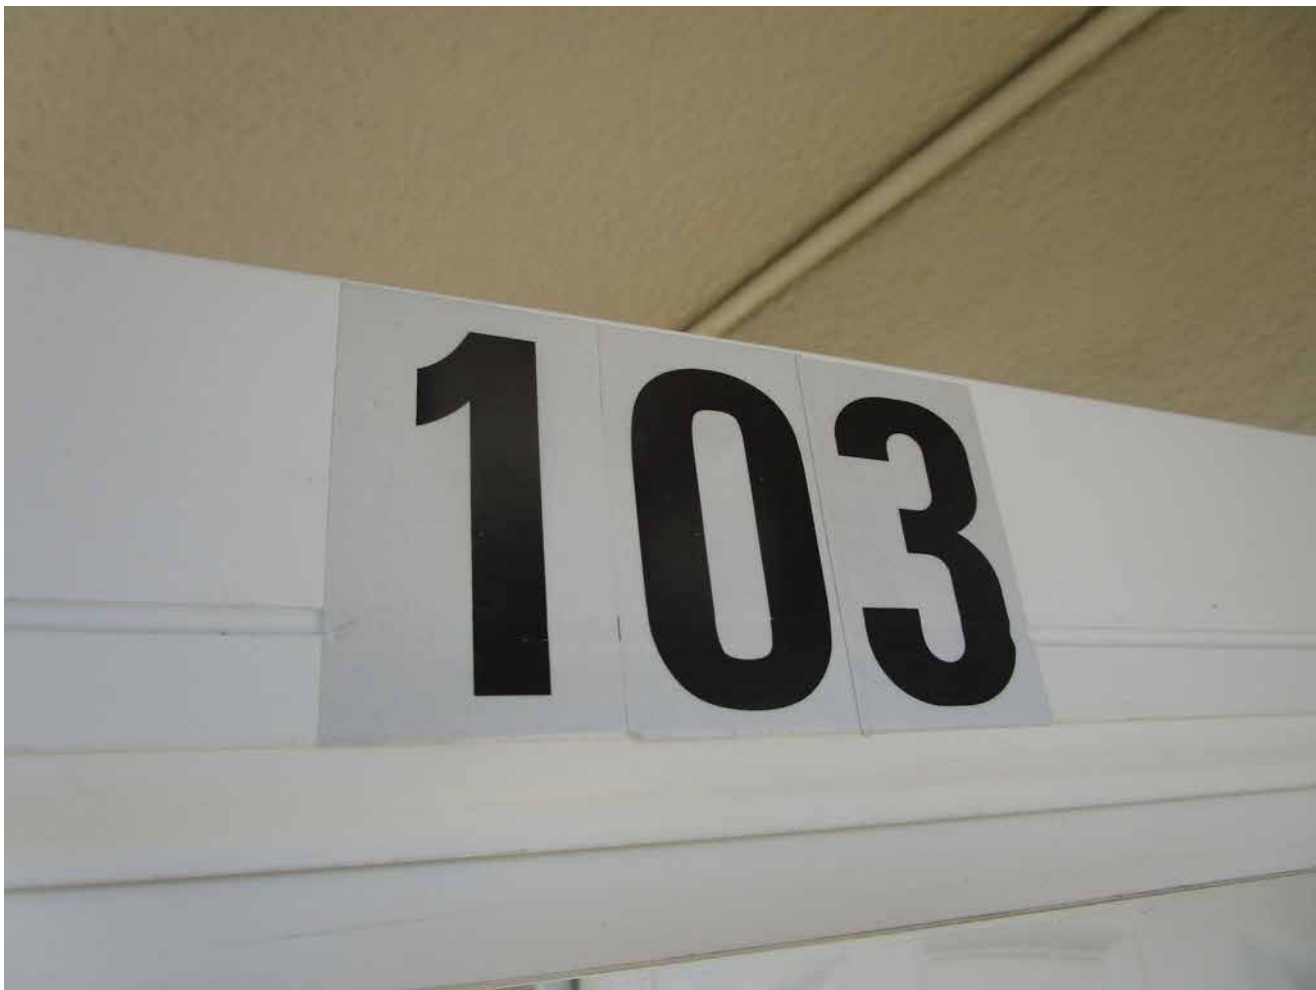
*Capri Isle Garden Apartments No. 2, Unit 103.*

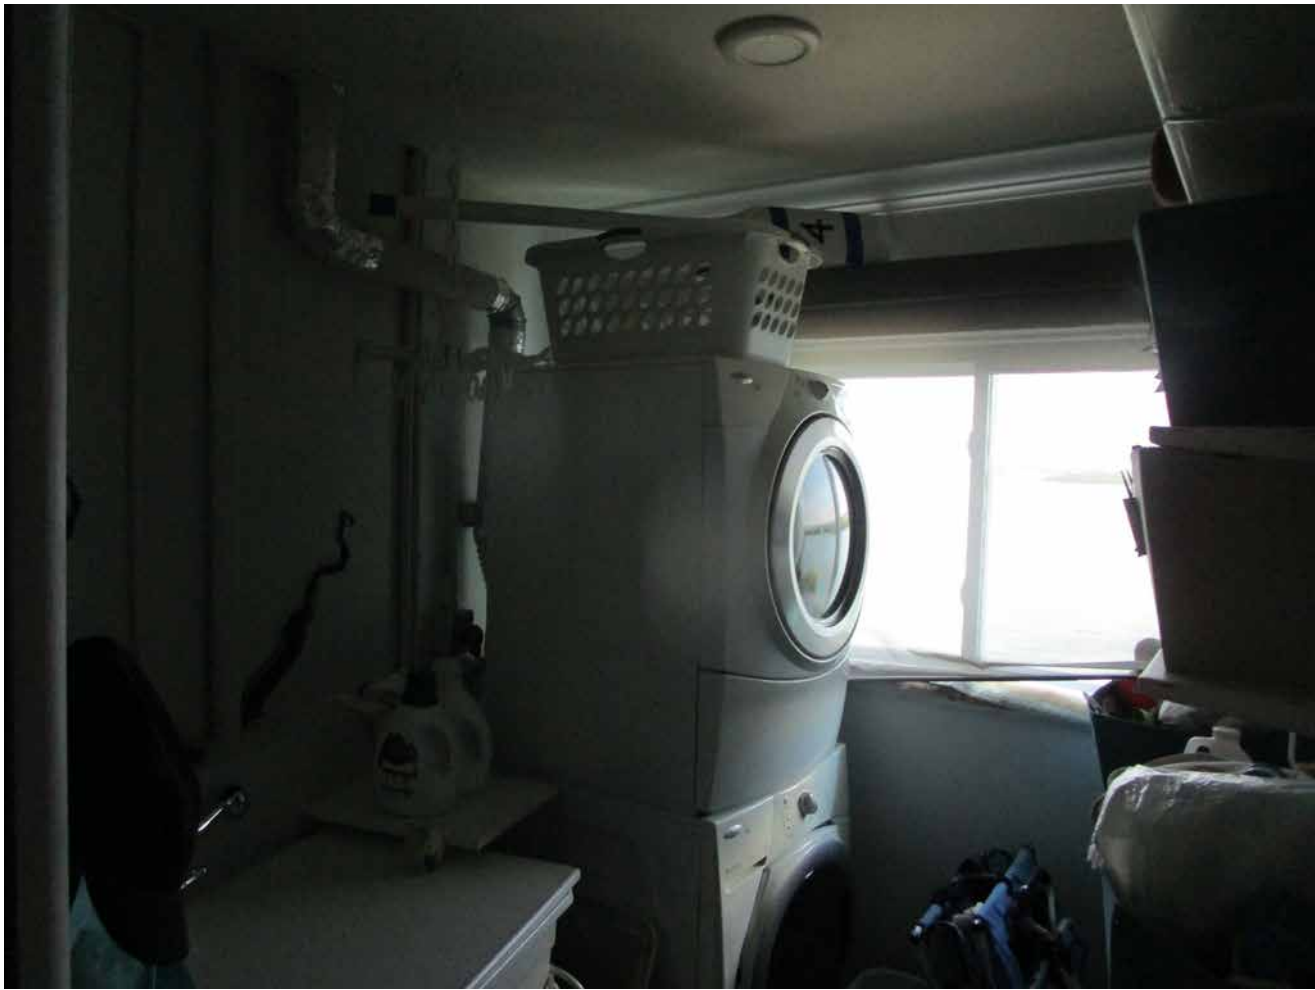
*Capri Isle Garden Apartments No. 2. Unit 401. Minor cracking in interior ceilings observed, which is typical for this construction. This is not a structural issue and no action is required.*

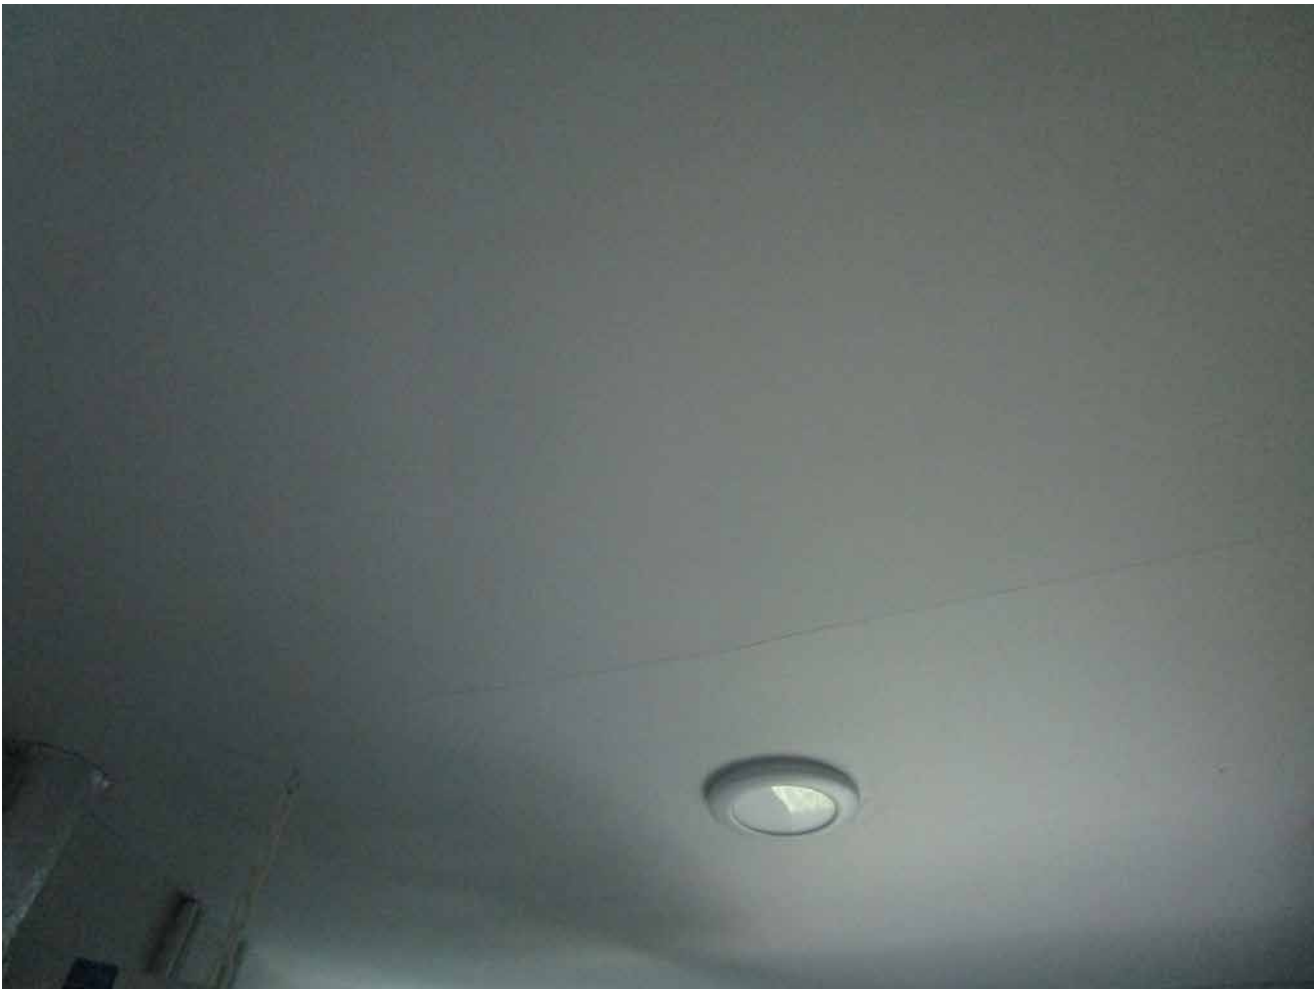
*Capri Isle Garden Apartments No. 2. Unit 401. Minor cracking in interior ceilings observed, which is typical for this construction. This is not a structural issue and no action is required.*

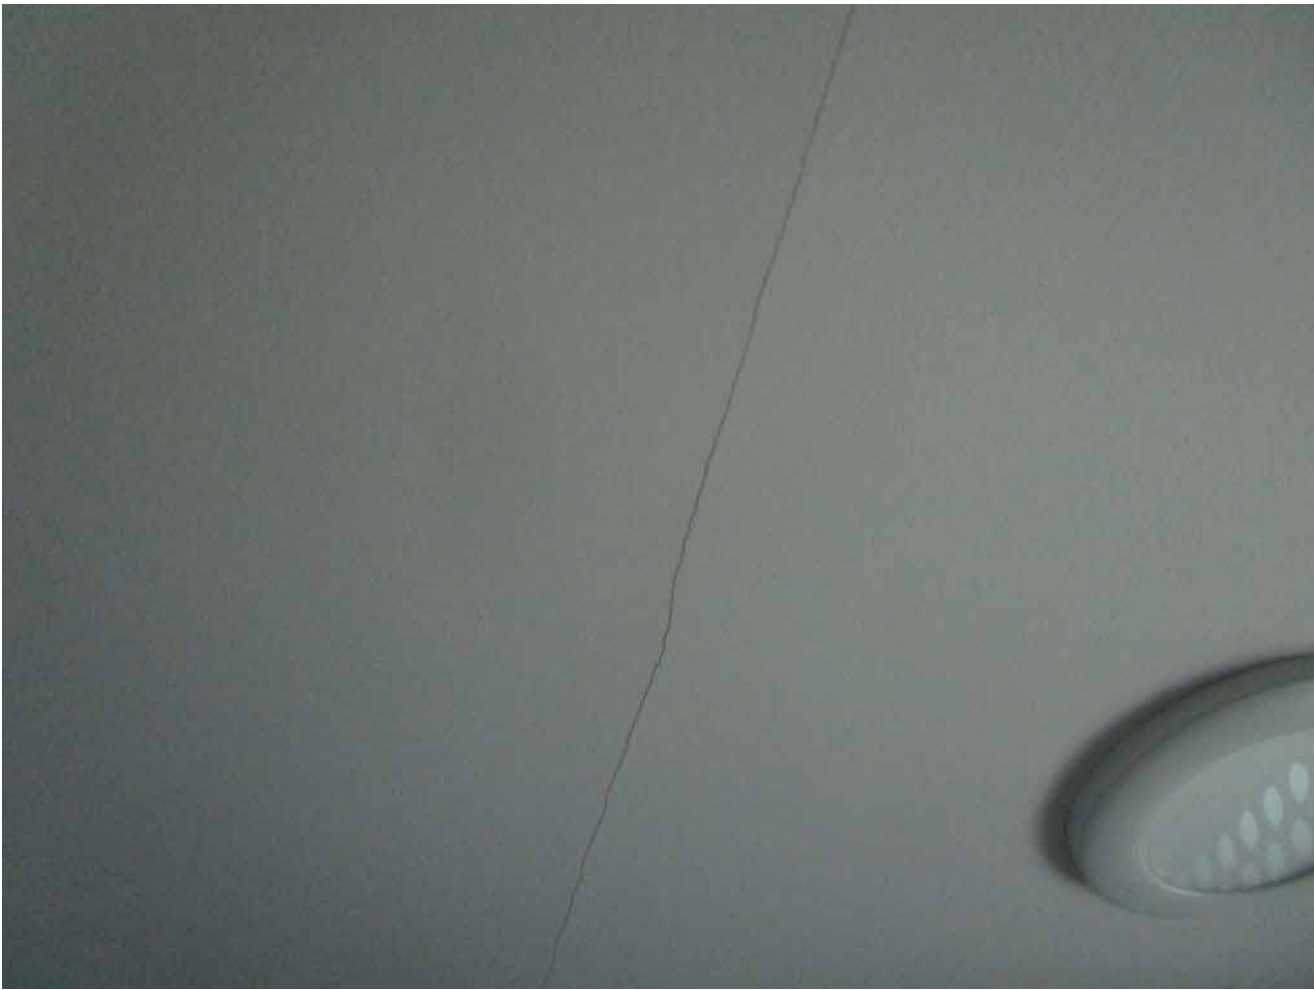
*Capri Isle Garden Apartments No. 2. Unit 401. Minor cracking in interior ceilings observed, which is typical for this construction. This is not a structural issue and no action is required.*

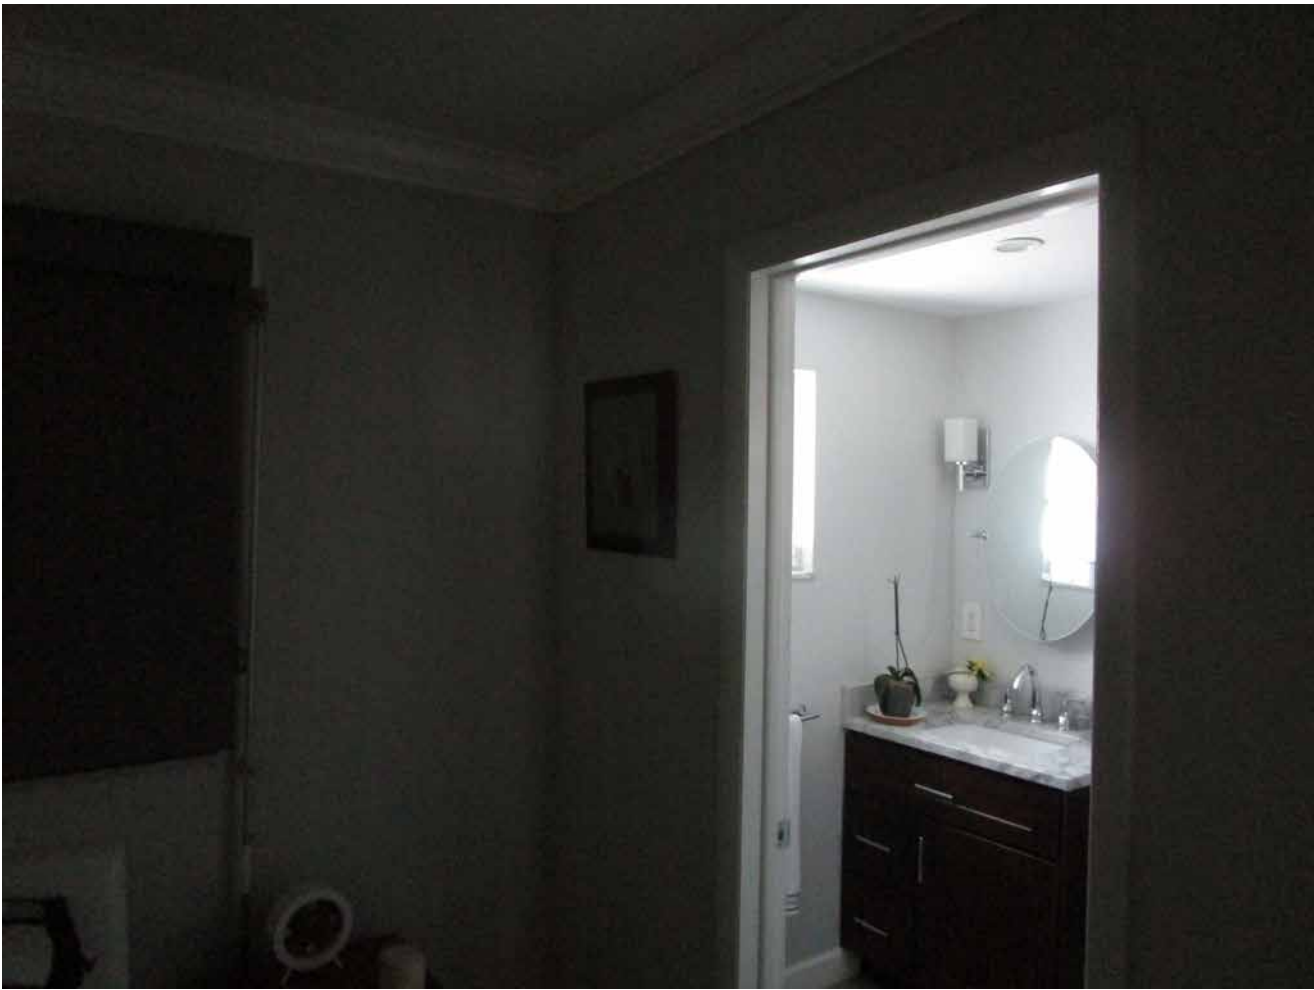
*Capri Isle Garden Apartments No. 2, Unit 401.*

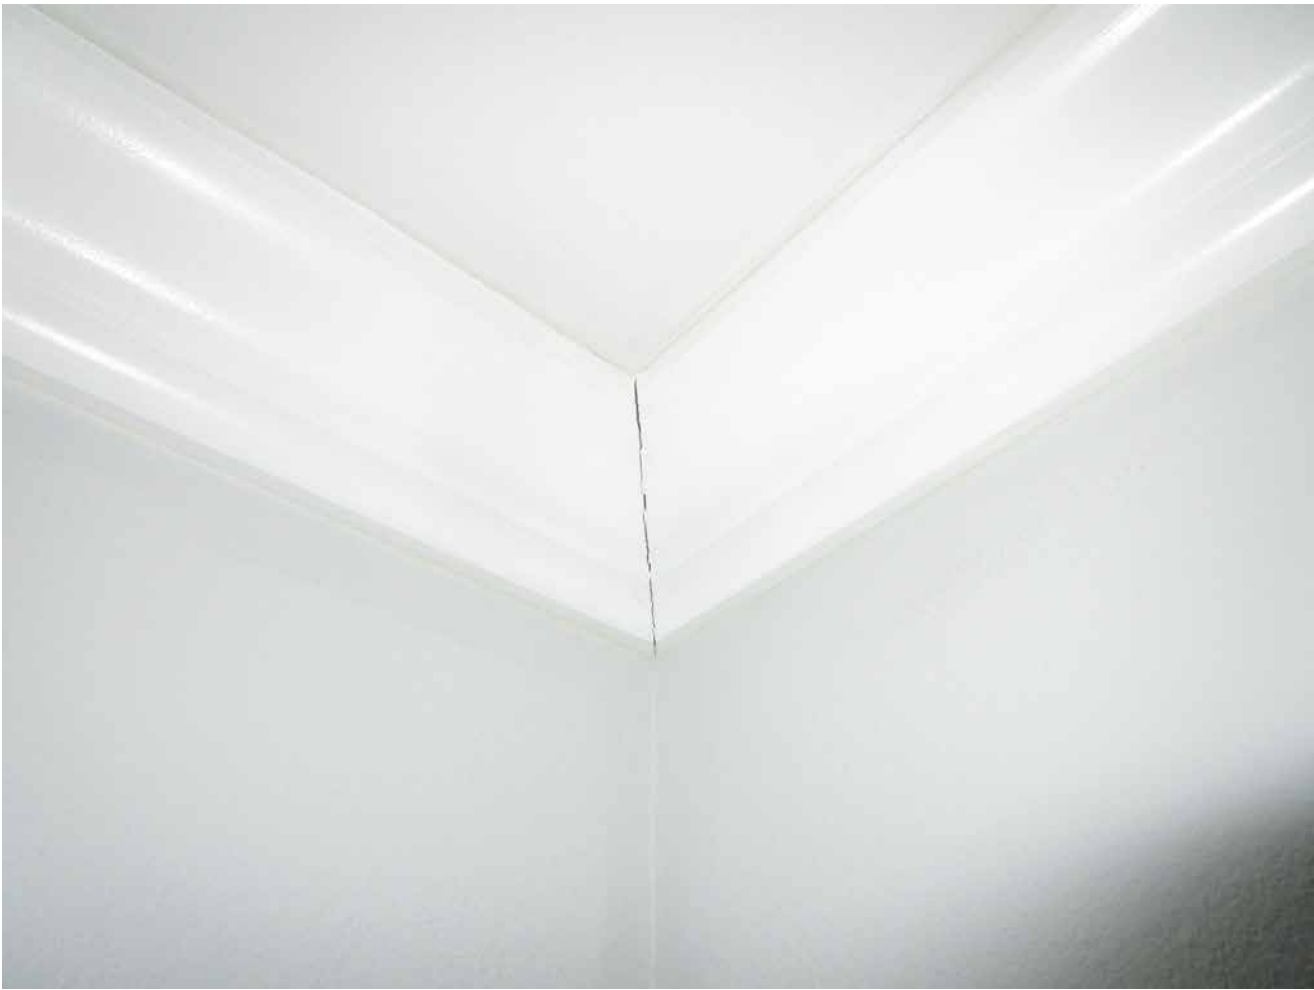
*Capri Isle Garden Apartments No. 2, Unit 401. Minor cracking in crown moulding at ceiling. This is a joint where two pieces are joined together. Not a structural issue--no action required.*

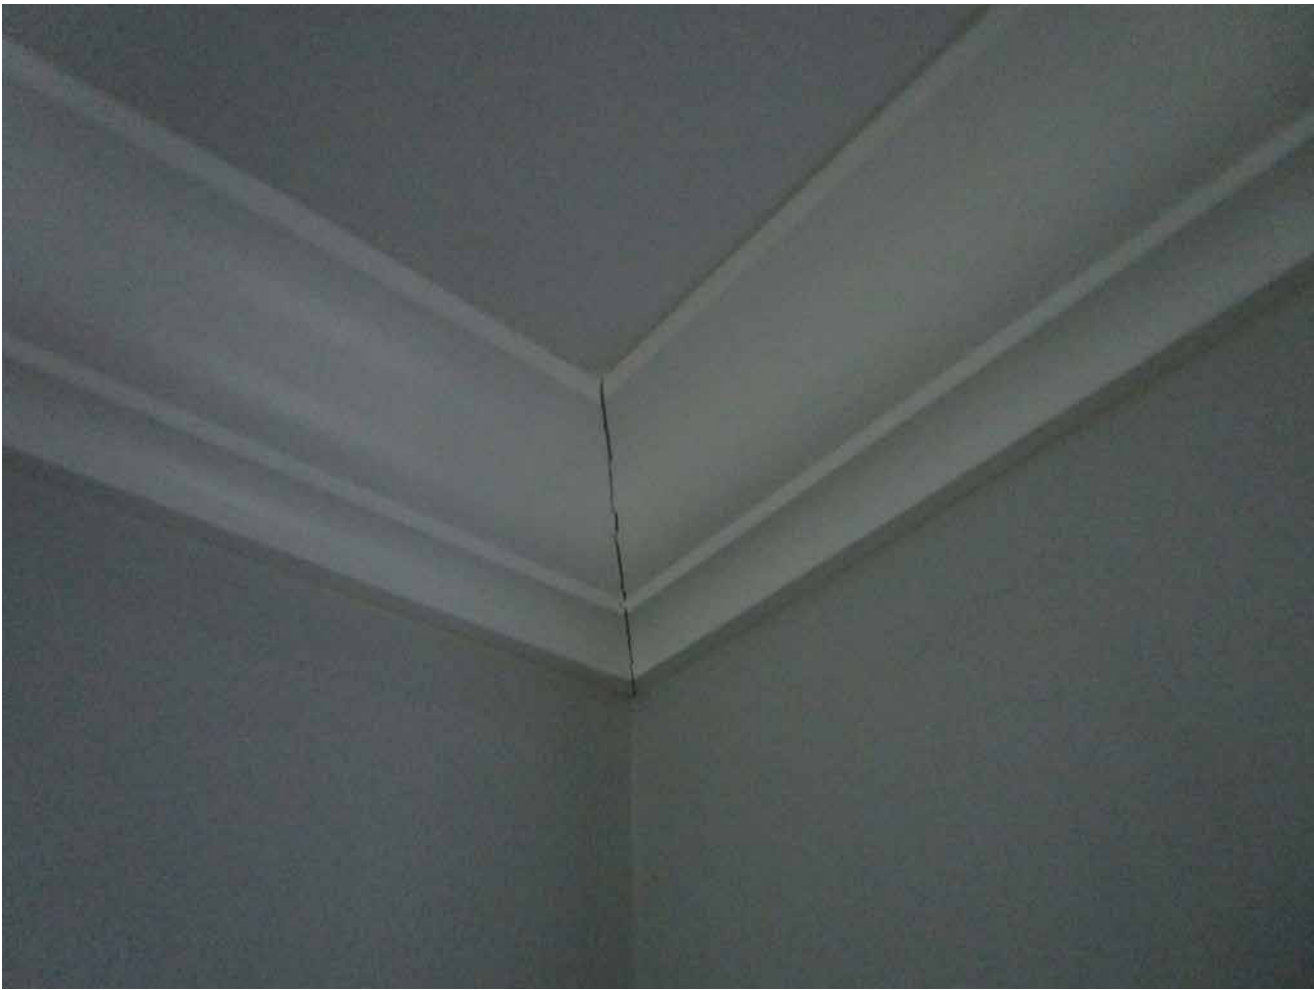
*Capri Isle Garden Apartments No. 2, Unit 401. Minor cracking in crown moulding at ceiling. This is a joint where two pieces are joined together. Not a structural issue--no action required.*

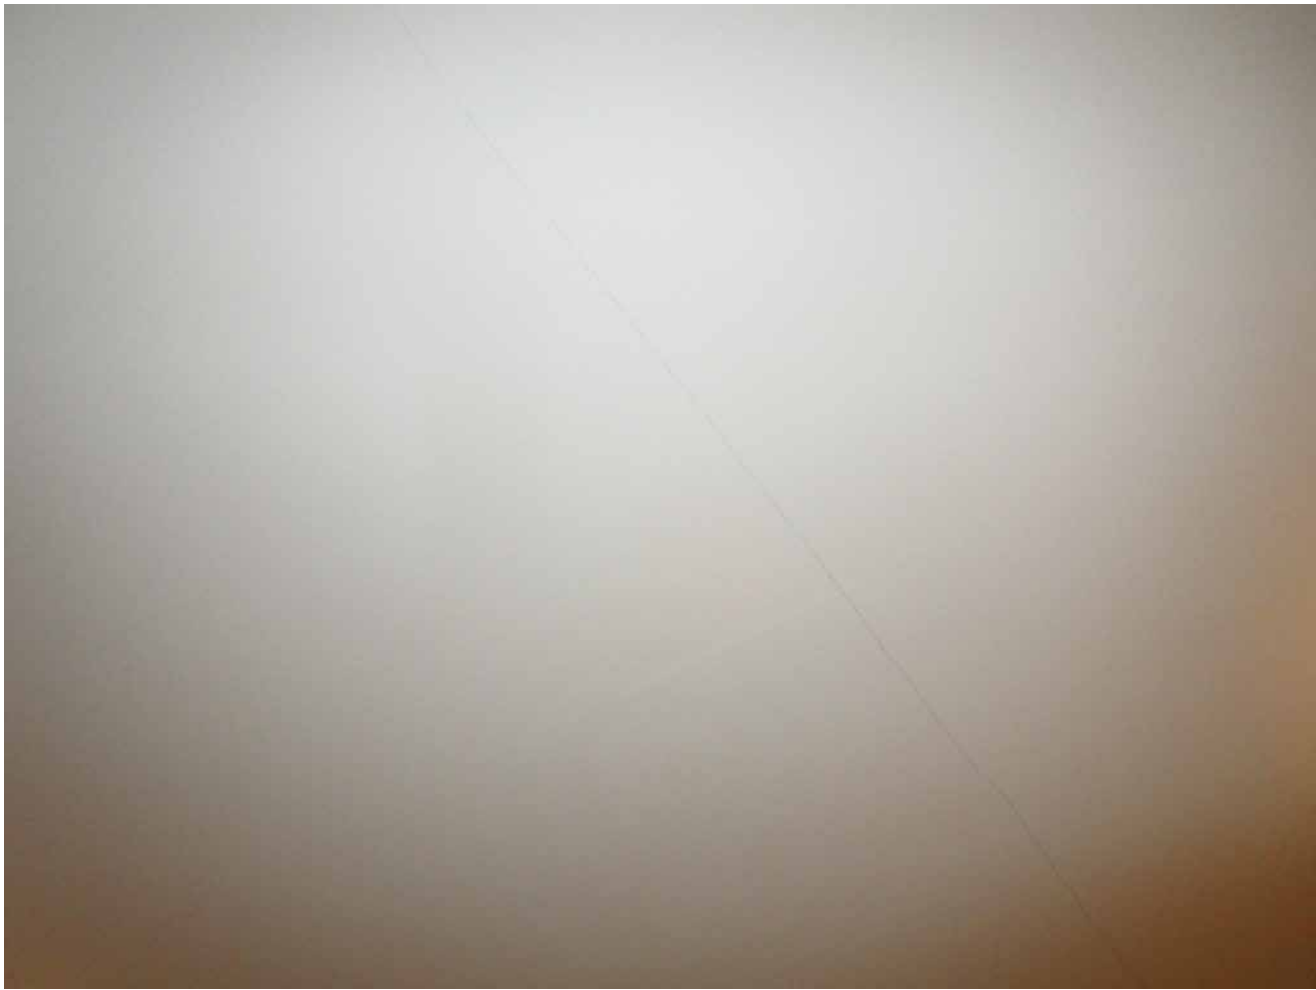
*Capri Isle Garden Apartments No. 2. Unit 401. Minor cracking in ceiling observed--not a structural issue and no action is required.*

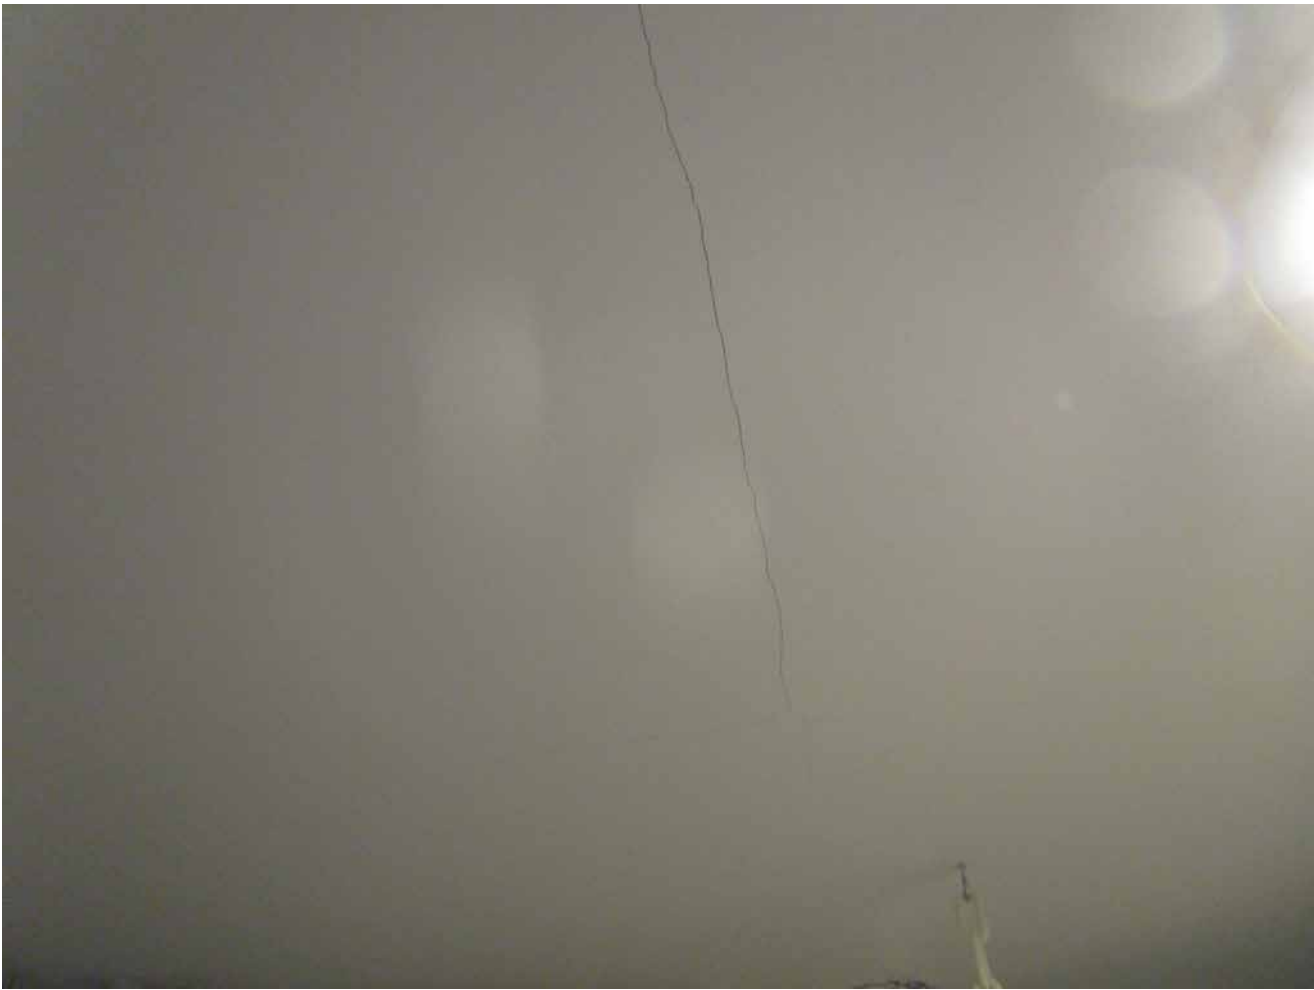
*Capri Isle Garden Apartments No. 2. Unit 401. Minor cracking in ceiling observed--not a structural issue and no action is required.*

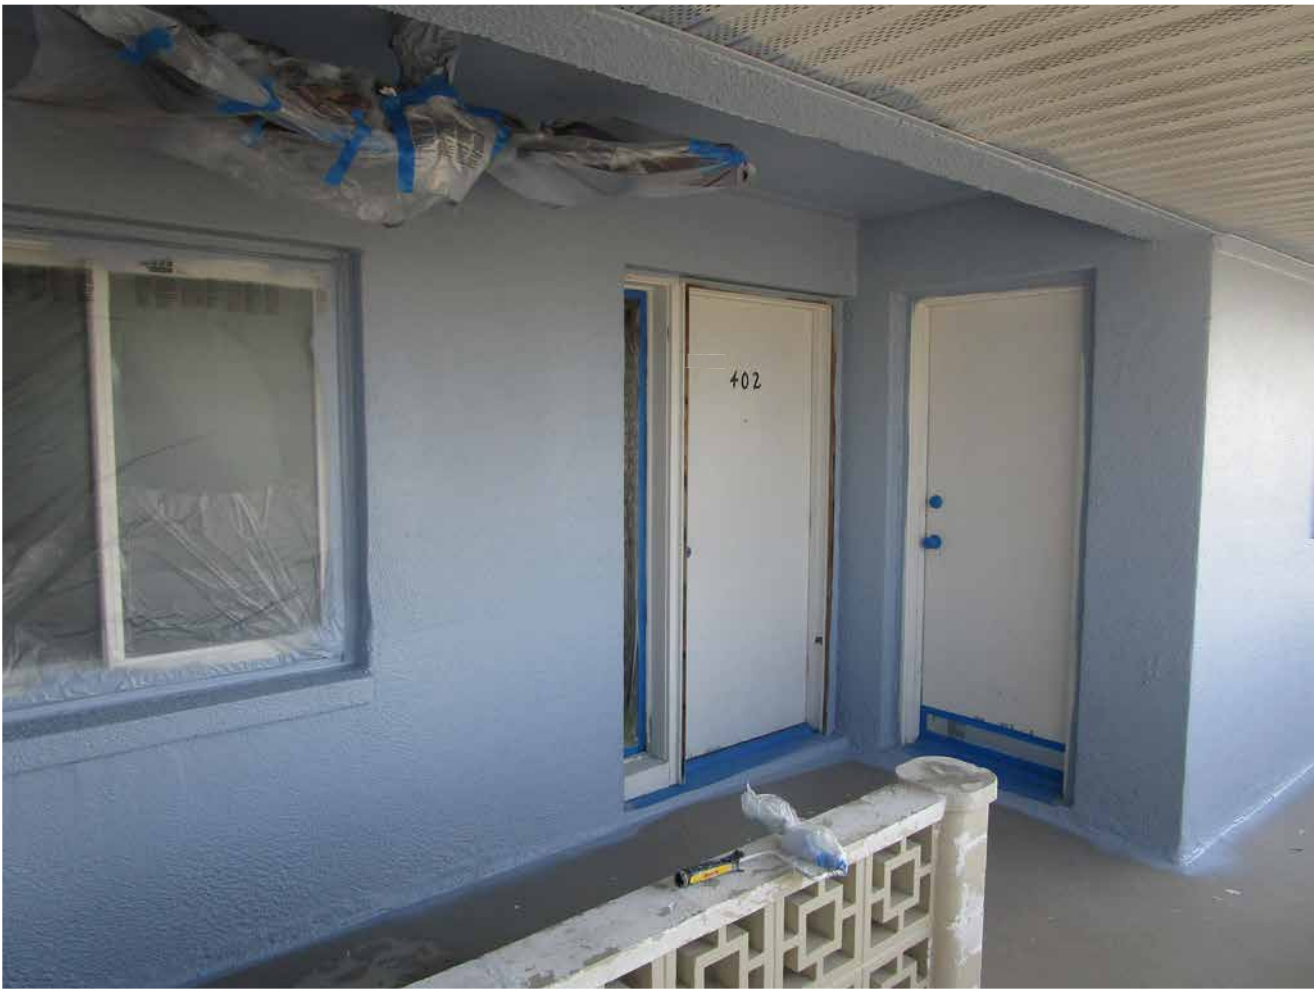
*Capri Isle Garden Apartments No. 2. Unit 402.*

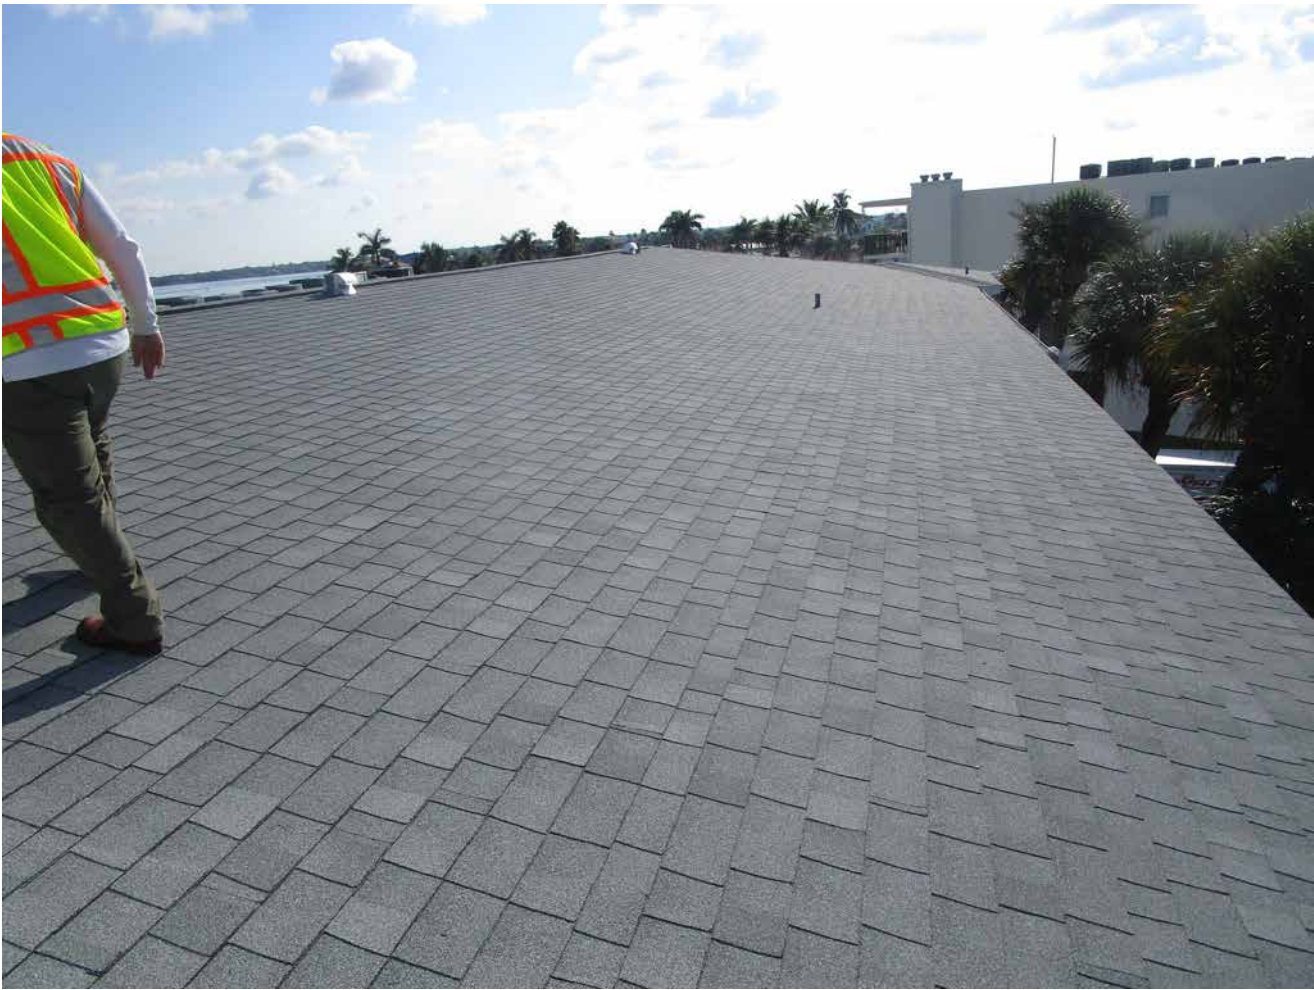
*Capri Isle Garden Apartments No. 2. Roof shingles are in good condition.*

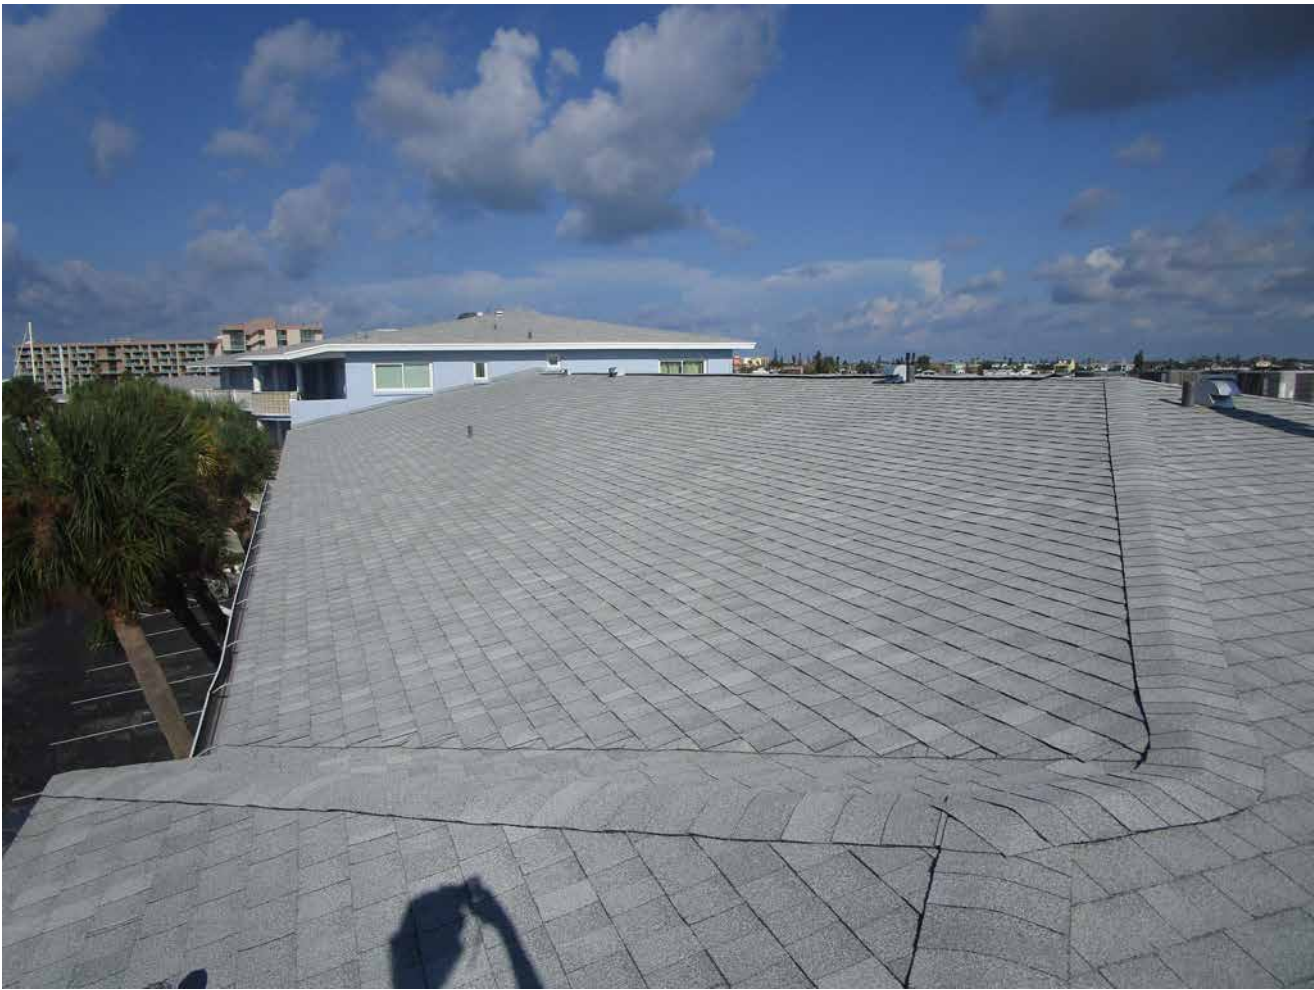
*Capri Isle Garden Apartments No. 2.*

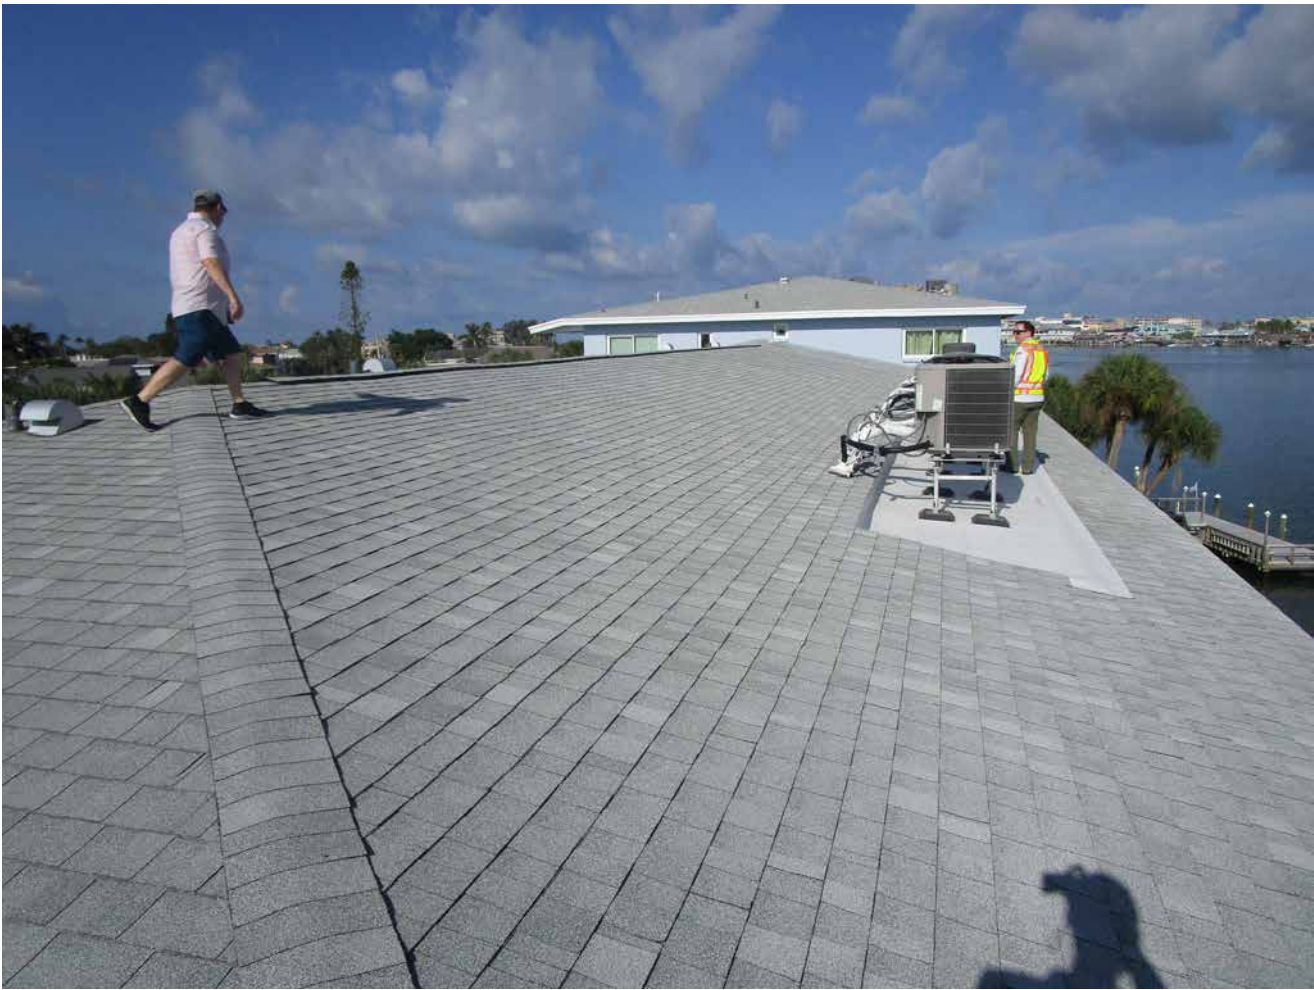
*Capri Isle Garden Apartments No. 2. Roof is in good condition. No significant issues observed.*

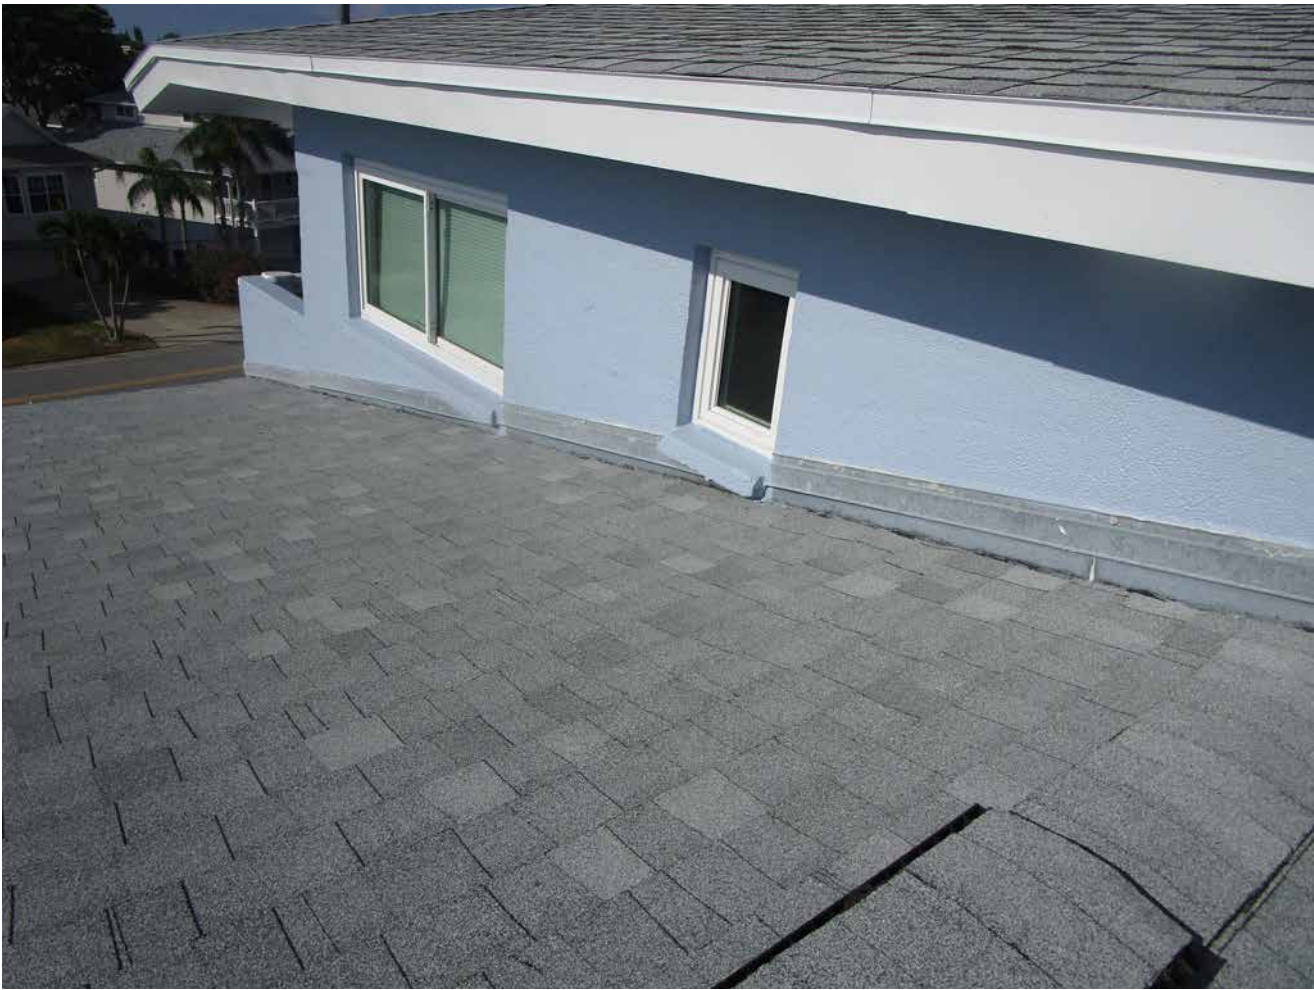
*Capri Isle Garden Apartments No. 2.*
