November 9, 2023

THIS MILESTONE PHASE 1 INSPECTION REPORT WAS PRODUCED FOR CAPRI ISLE GARDEN APARTMENTS NO. 2 CONDOMINIUM ASSOCIATION, INC. LOCATED AT 280 126TH AVE, TREASURE ISLAND, FL 33706.

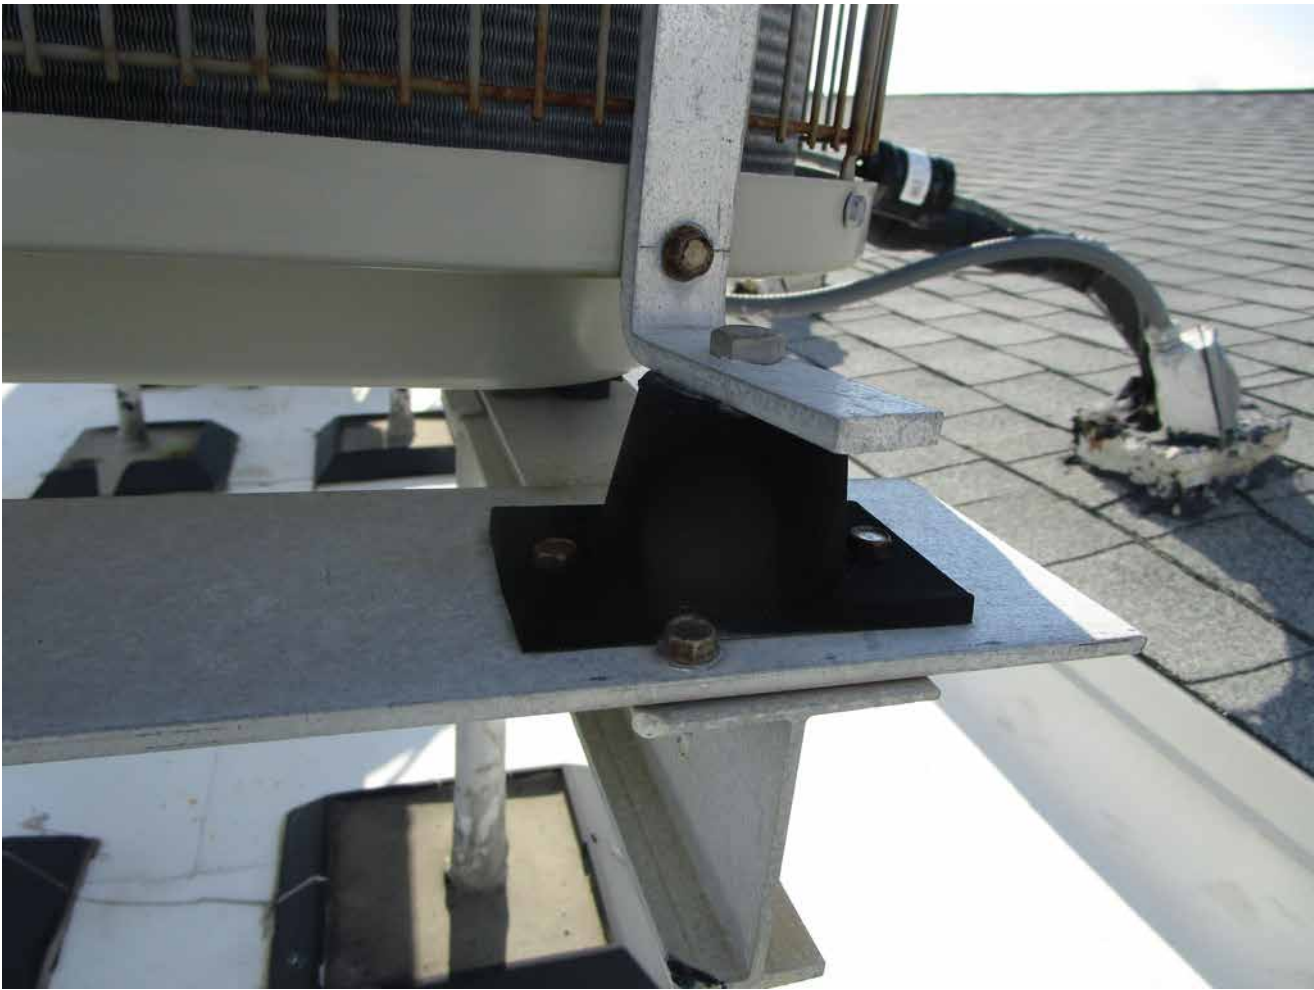
*Capri Isle Garden Apartments No. 2. Air conditioner condensing units are properly secured to rooftop equipment rack.*

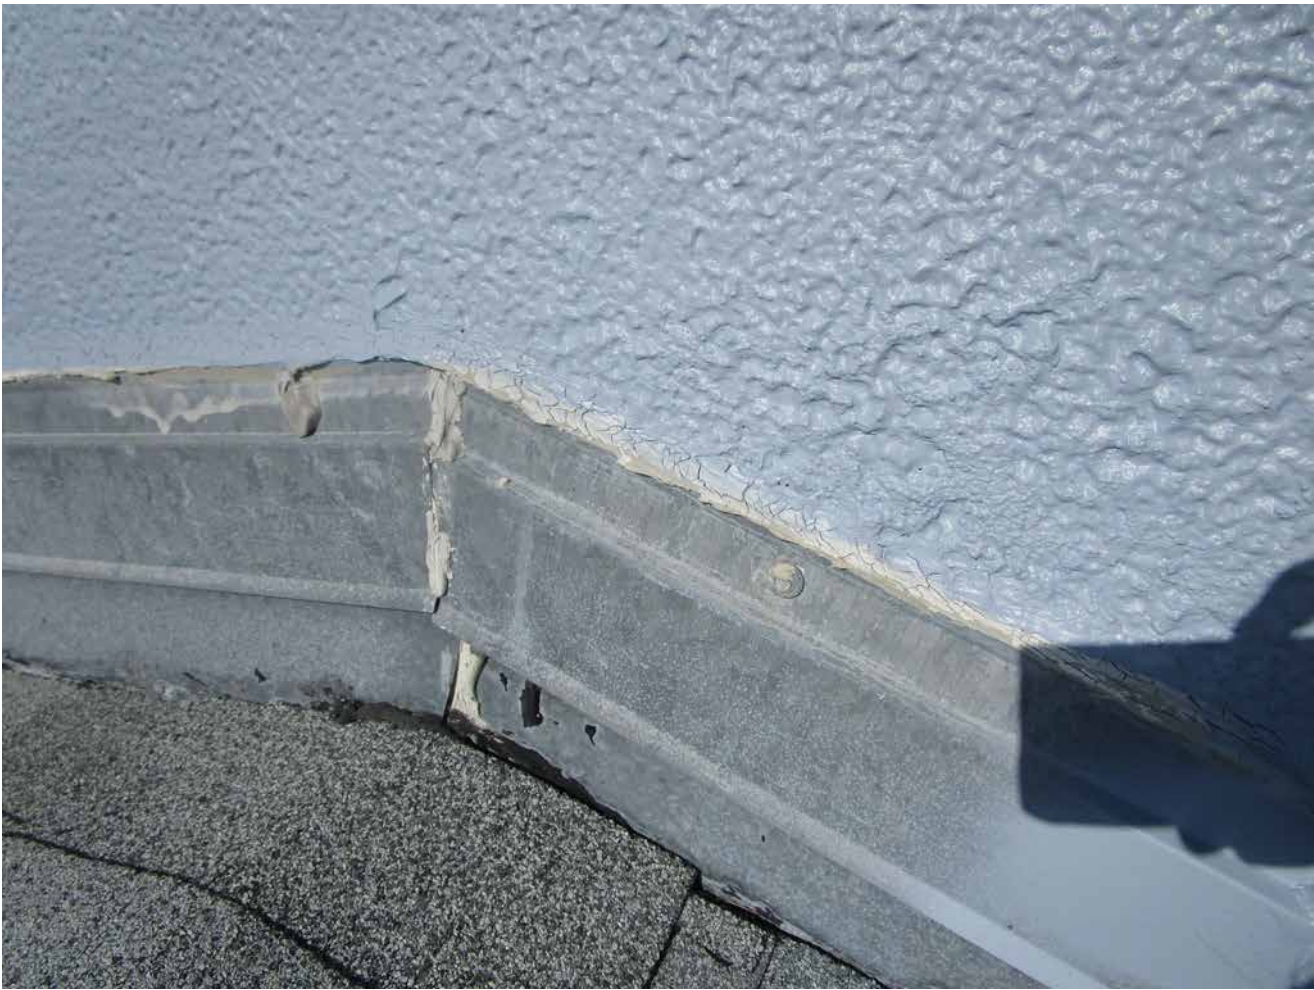
*Capri Isle Garden Apartments No. 2. Sealants at top of counterflashing on roof level are deteriorating and reaching the end of their useful life. Recommend removal and replacement of these sealants.*

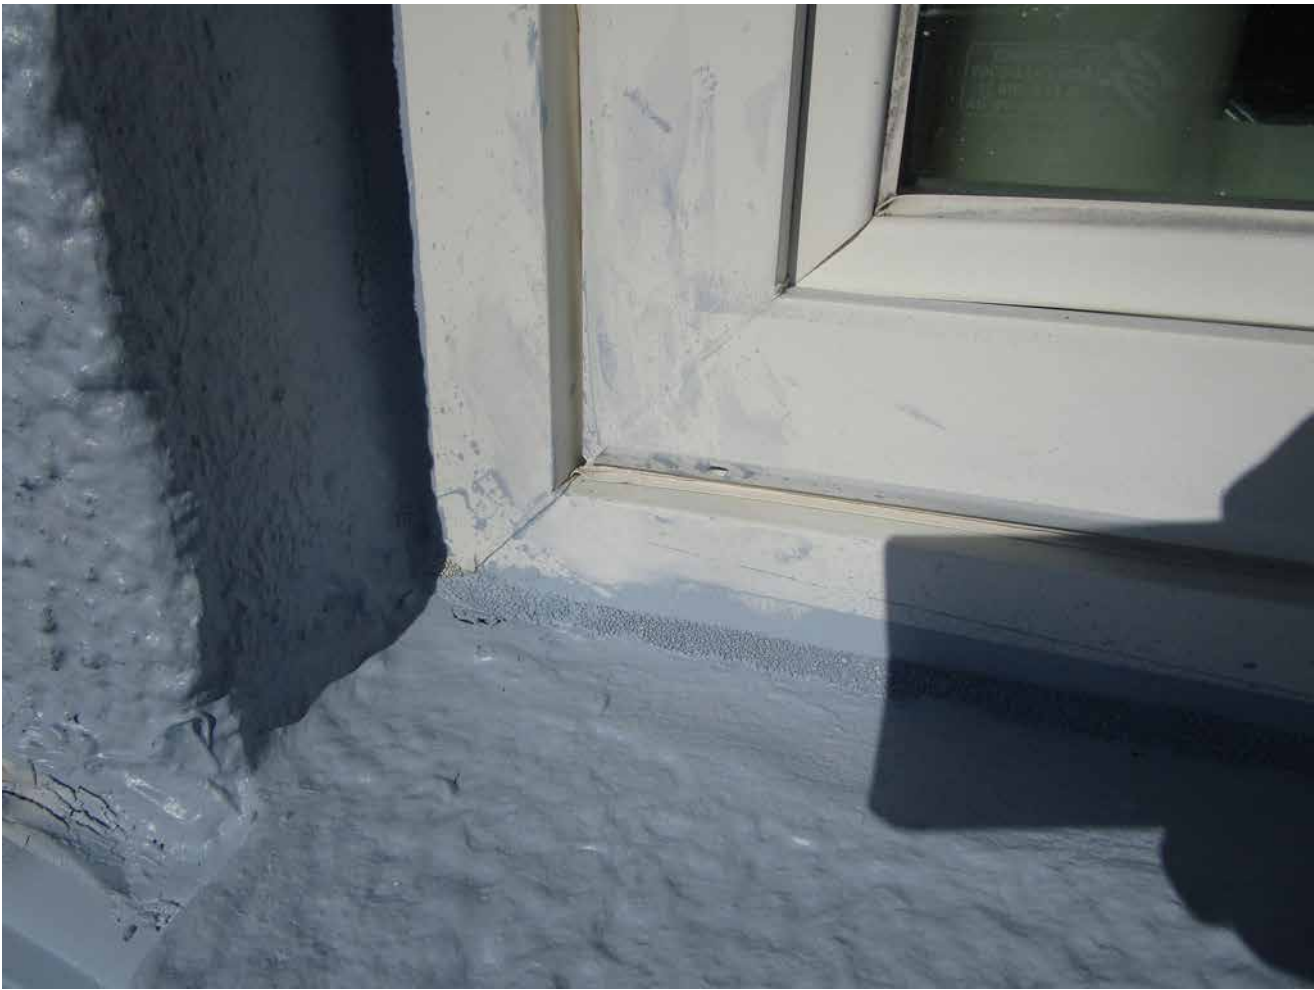
*Capri Isle Garden Apartments No. 2. Window perimeter sealants at roof level are deteriorating and reaching the end of their useful life. Recommend removal and replacement of these sealants.*

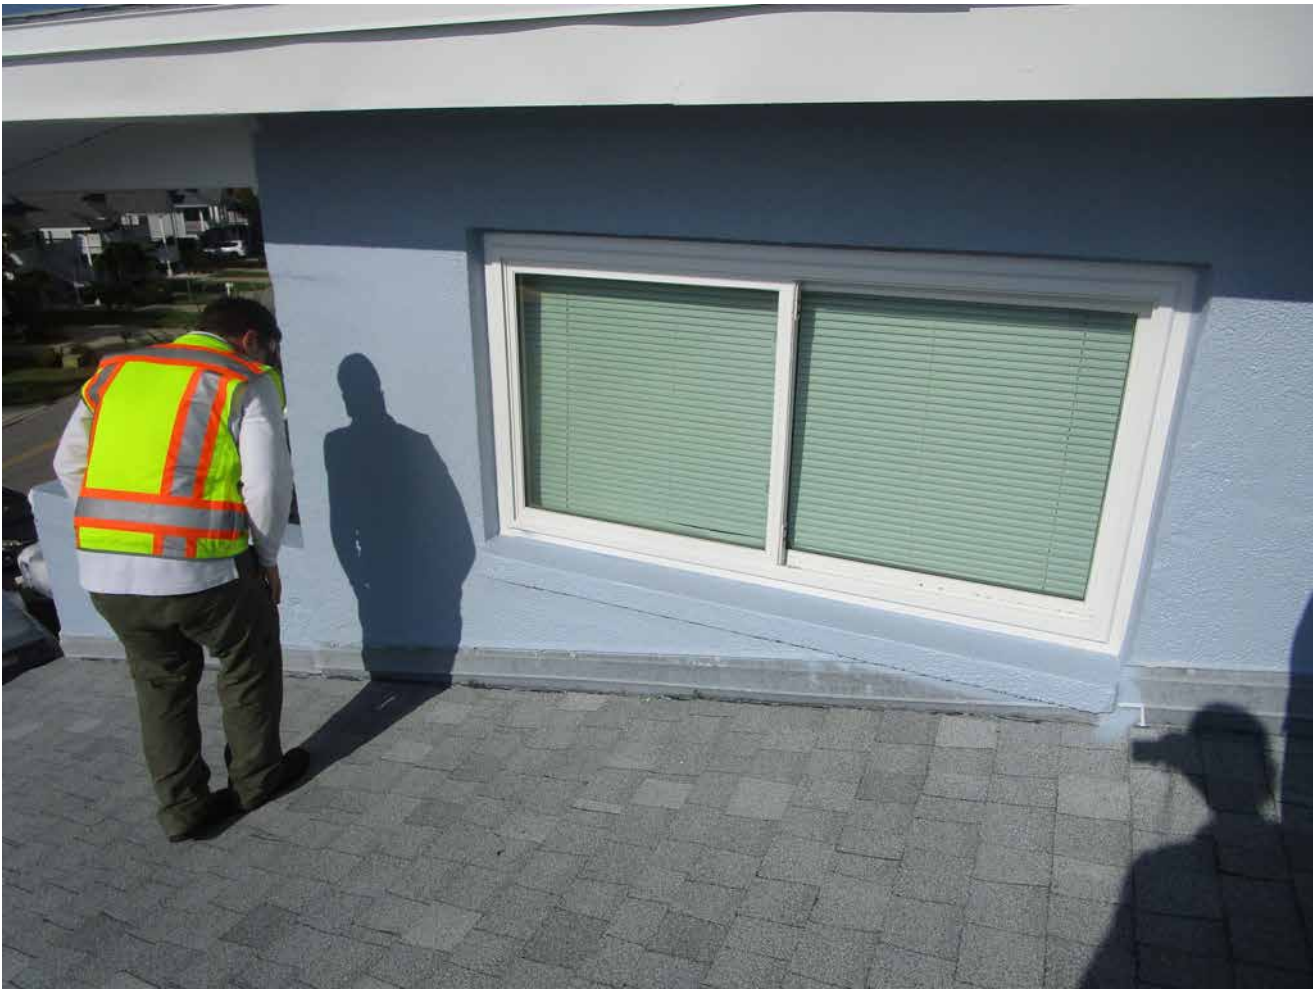
*Capri Isle Garden Apartments No. 2. Window perimeter sealants at roof level are deteriorating and reaching the end of their useful life. Recommend removal and replacement of these sealants.*

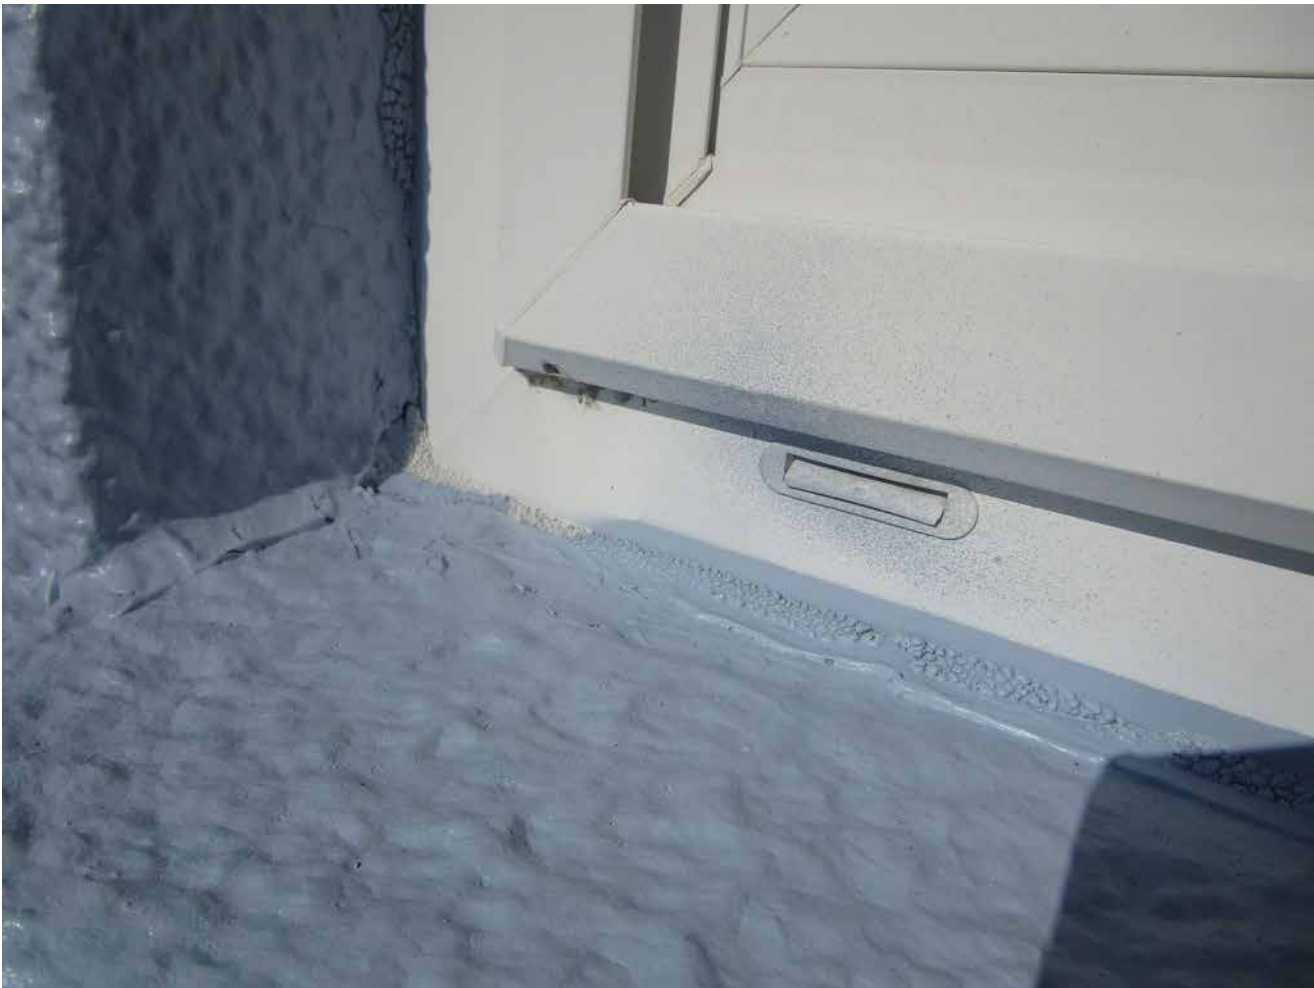
*Capri Isle Garden Apartments No. 2. Window perimeter sealants at roof level are deteriorating and reaching the end of their useful life. Recommend removal and replacement of these sealants.*

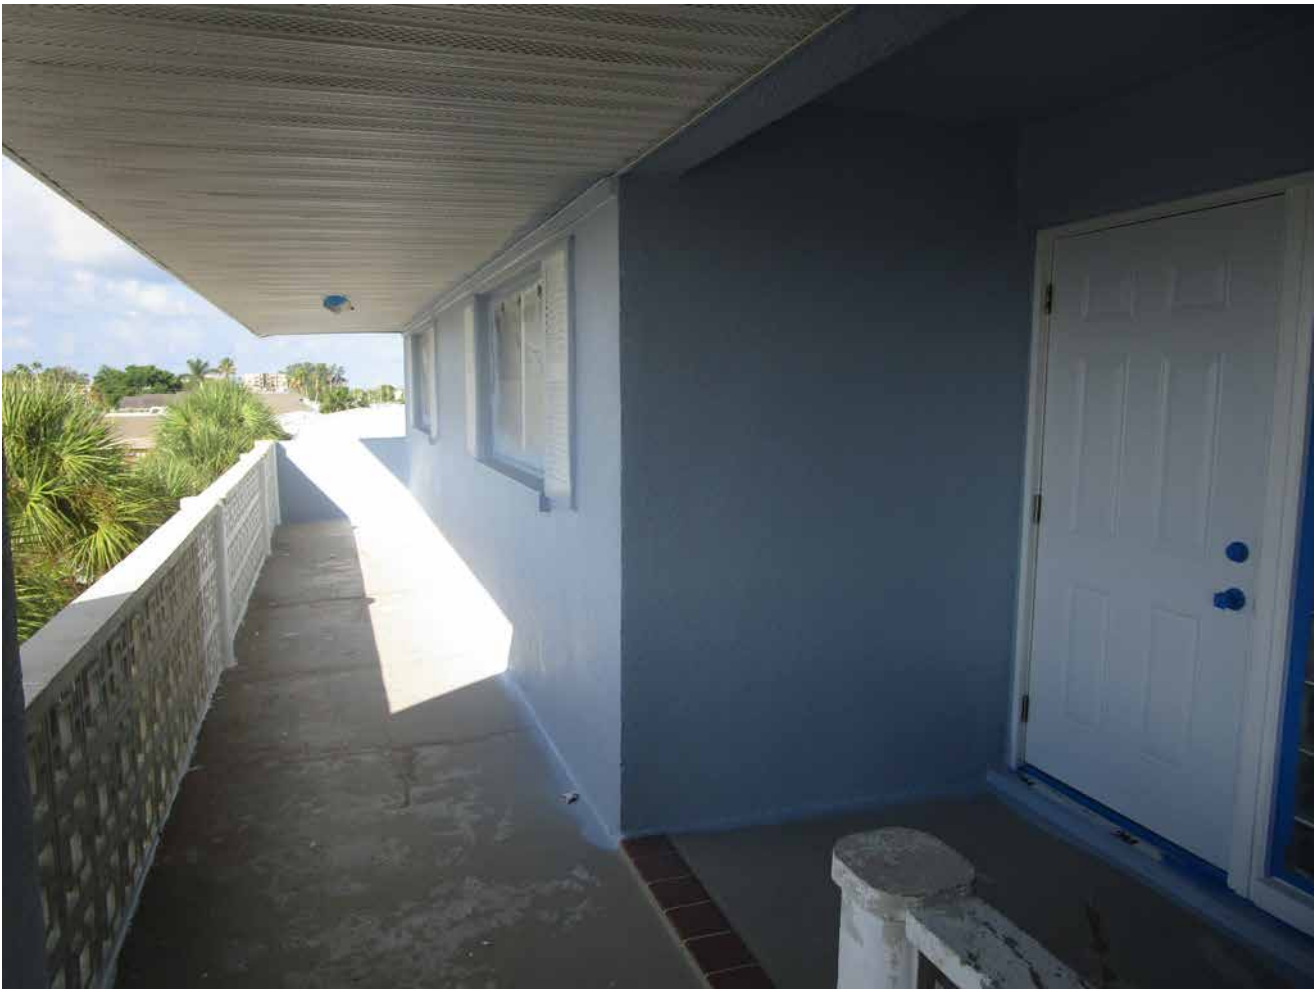
*Capri Isle Garden Apartments No. 2 , typical walkway area.*

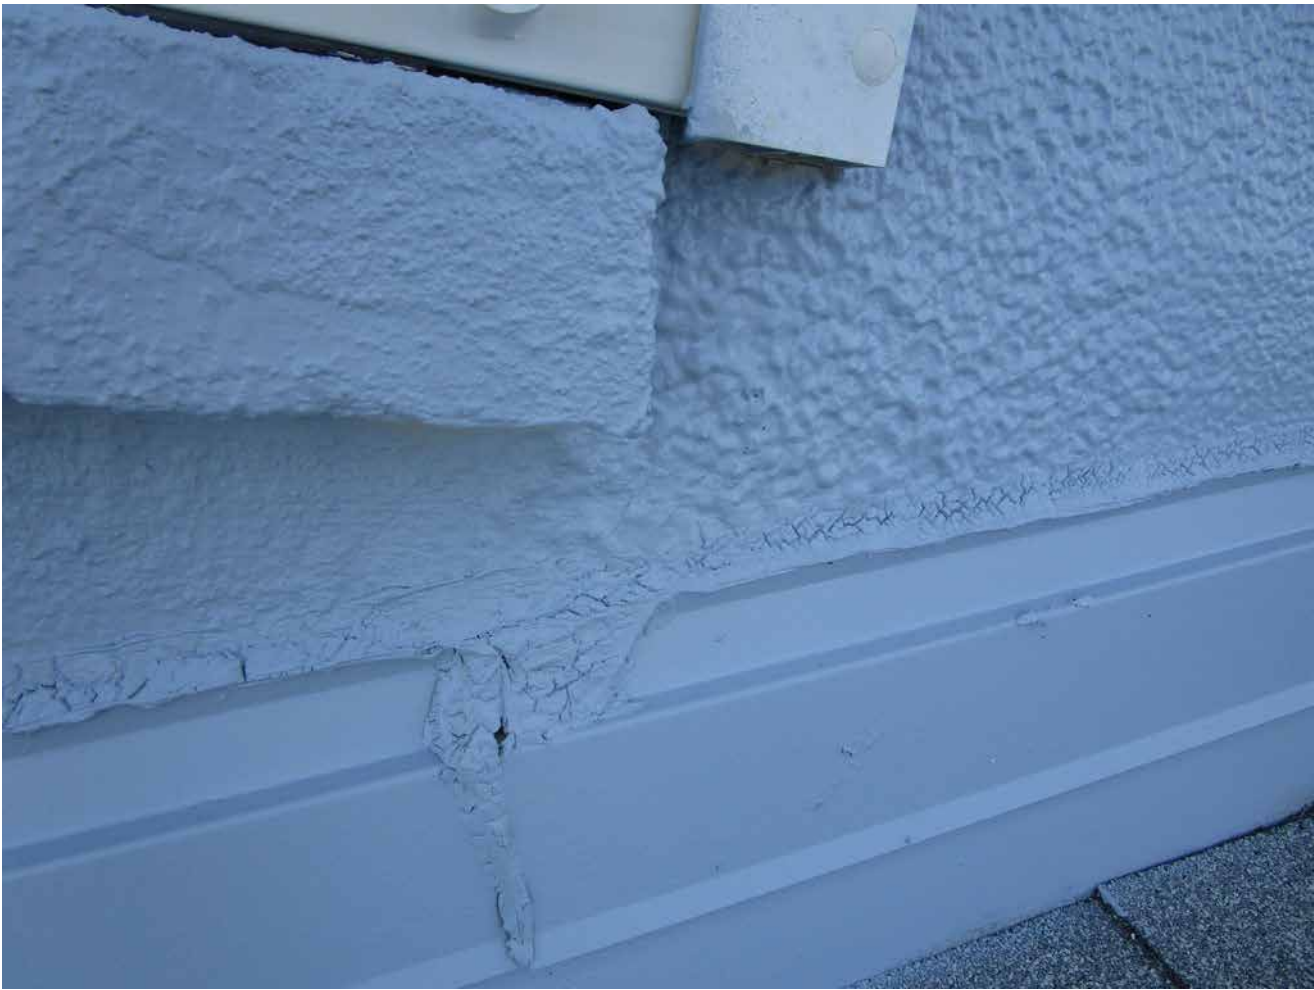
*Capri Isle Garden Apartments No. 2. Typical deteriorated sealants at rooftop counter flashing. Recommend replacement as preventative maintenance.*

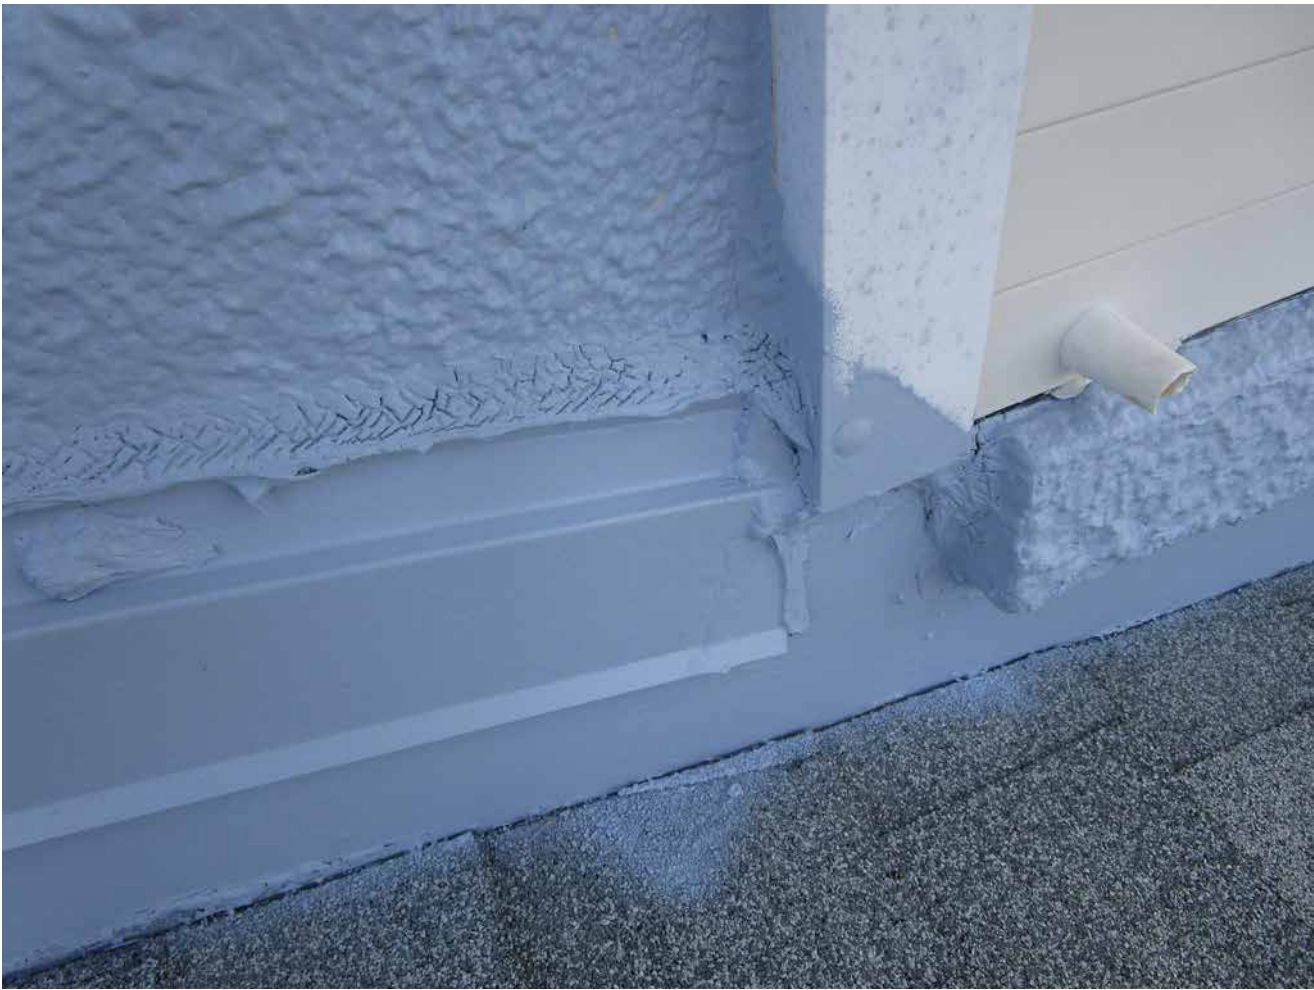
*Capri Isle Garden Apartments No. 2. Typical deteriorated sealants at rooftop counter flashing. Recommend replacement as preventative maintenance.*

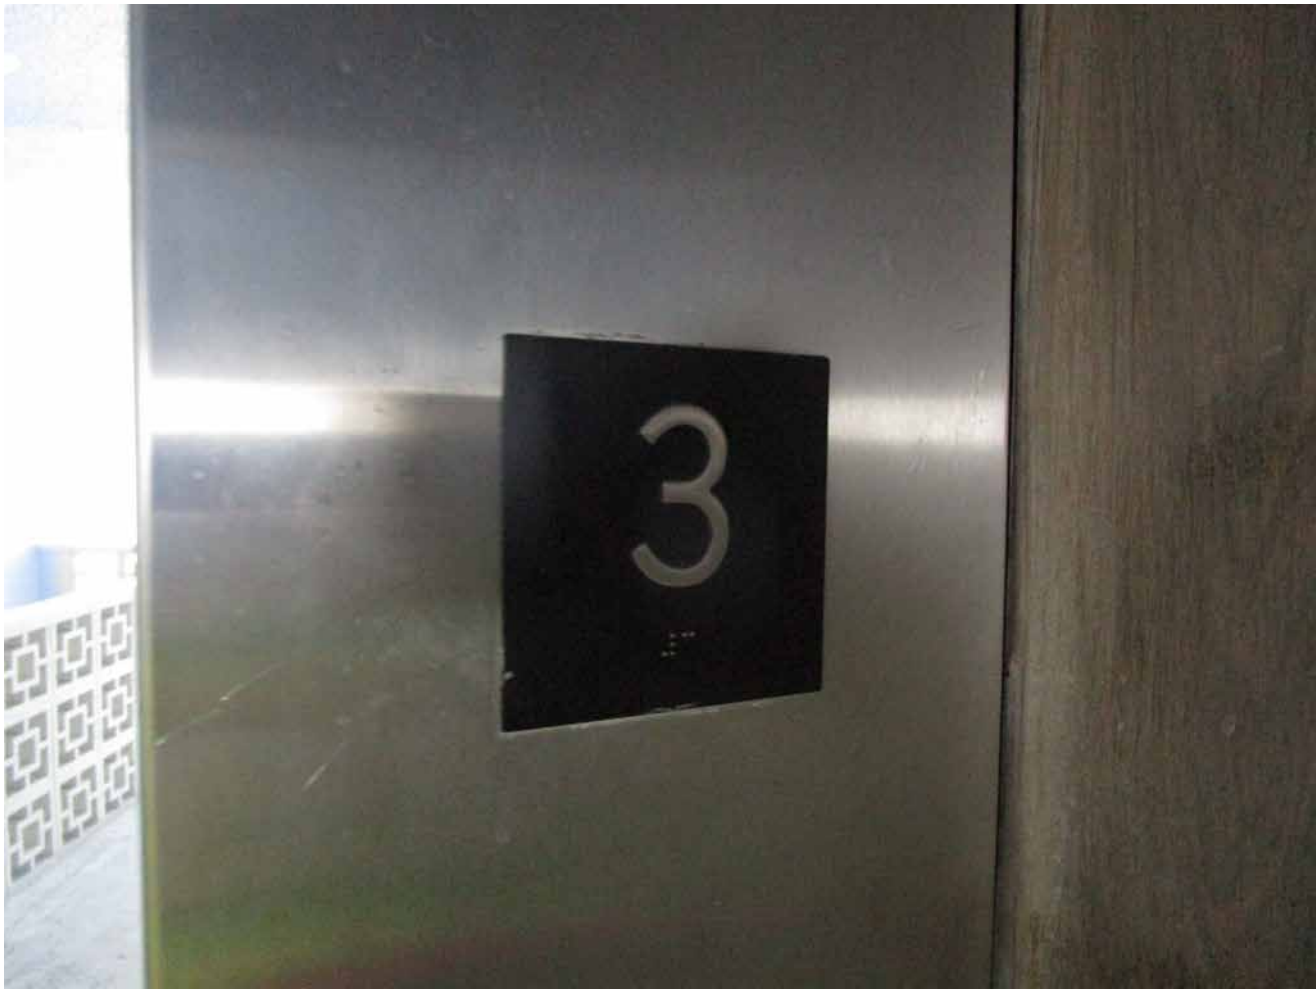
*Capri Isle Garden Apartments No. 2.*
