July 13, 2023

**Re: Seawall Inspection Report for Capri Isle Garden Apartments  
280 126<sup>th</sup> Avenue, Treasure Island, FL 33706**

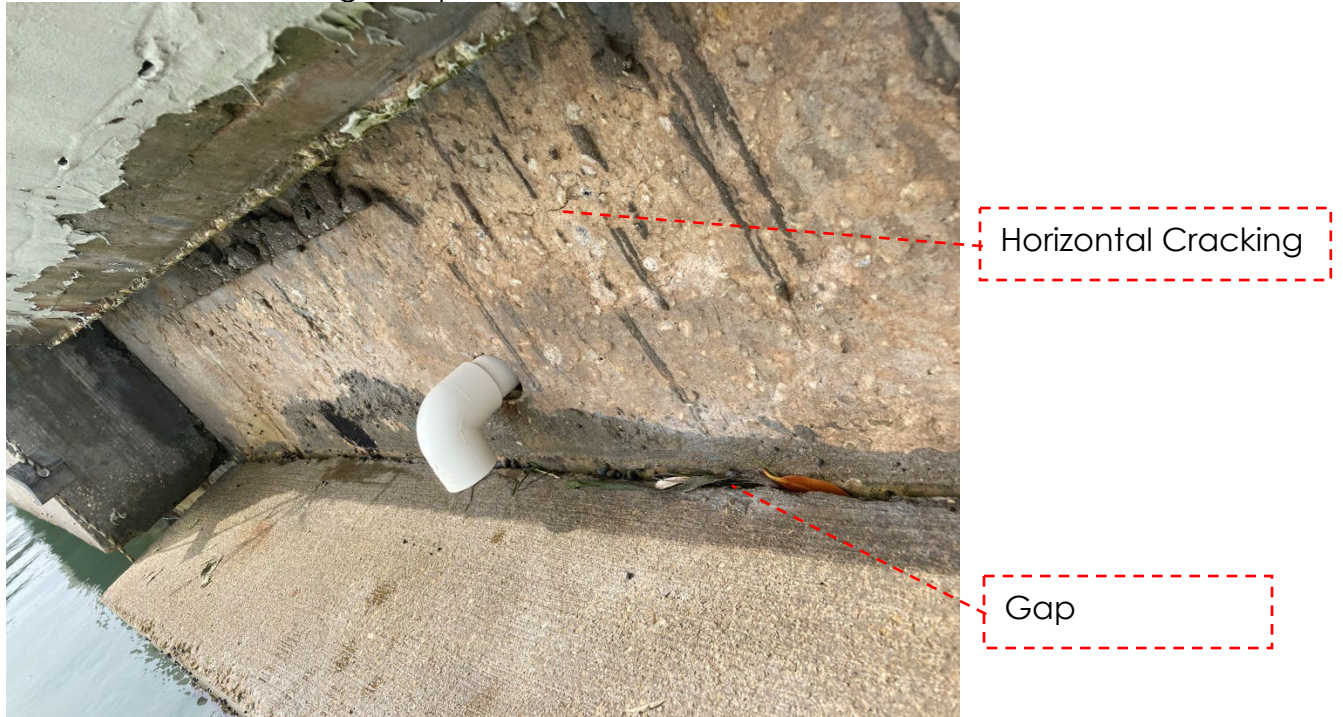
- At some point a stress beam was added for additional structural support of the wall.
- Stress beam is located 23” down from the top of the cap.
- A large gap between stress beam and vertical wall was observed throughout the length of the seawall. The gap indicates a loss of structural support from the stress beam and/or movement of the wall.
- Structural defects (horizontal/shear cracking and spalling) were observed in the stress beam indicating the rebars inside the concrete are starting to rust from salt intrusion.

Photo #1- View of Large Gap Between Stress Beam and Vertical Wall.

Due to the age, condition, and limited slab penetration of the existing seawall system we recommend planning on replacement of the existing seawall system within the next 6 months to 1± year. Recommended specifications for a new seawall would include construction of a new vinyl corrugated seawall system with a new concrete cap and 1” diameter HDG PVC encased tieback rods to MR-SR manta ray anchors or deadmen. Well point drains should be installed through both walls at 6’ on center and 5” above the barnacle line to relieve the hydrostatic pressure or aid in removing water from behind the wall. The existing wall would remain. Concrete filler would be applied between the two walls. The ballpark cost for this portion of wall in today’s prices is approximately \$329,800± with a useful life expectancy of 50 ± years.

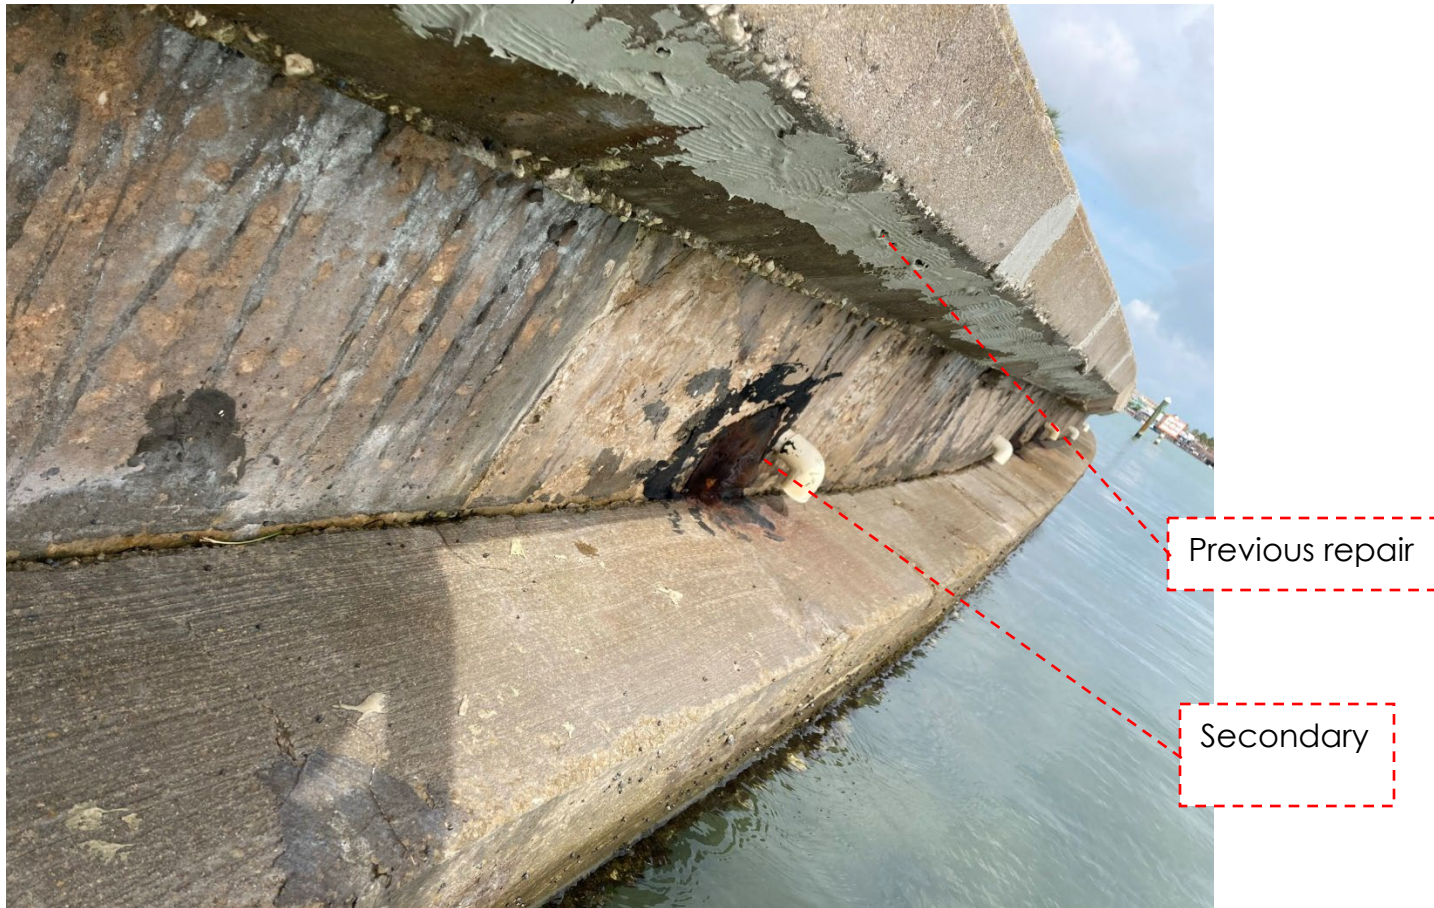
- The anchor plates/washers and nuts are in corroded/rusted condition indicating loss of structural support.
- Slab joints
  - Wellpoint drains were observed to relieve hydrostatic pressure or aid in removing water from behind the wall, however the slab joints are open and draining.

Photo #2 – View of Corroded Secondary Anchor Washers and Nuts.

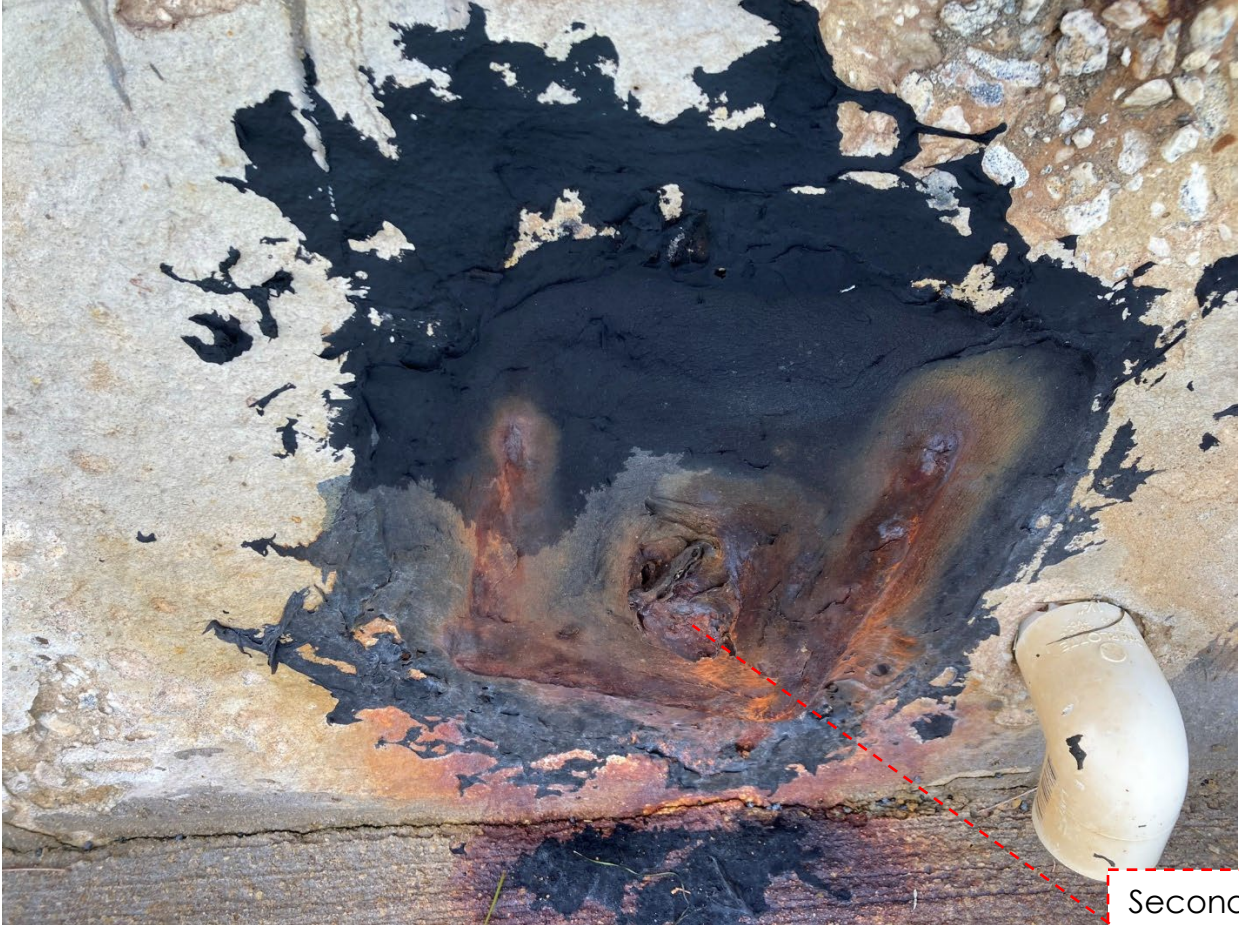
Photo #3- View of Corroded Secondary Anchor Washers and Nuts.

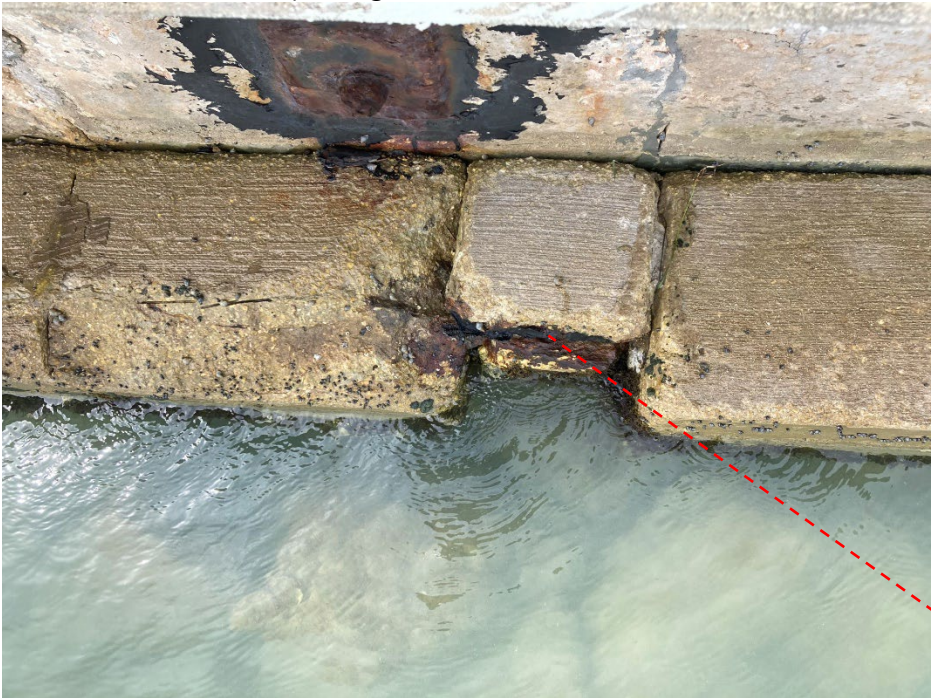
Photo #4- View of Spalling Stress Beam.

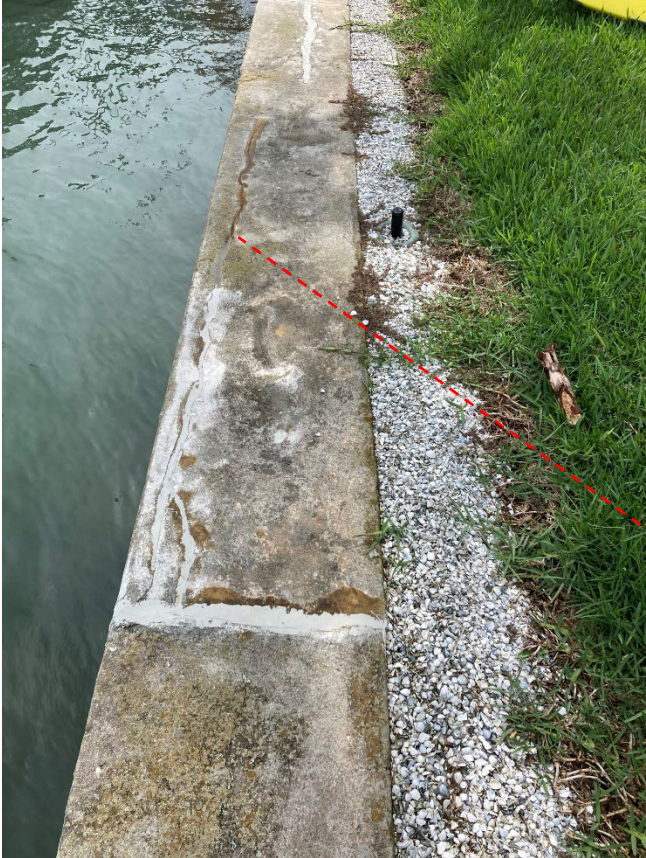
- 309 LF +/- of seawall cap.
- Longitudinal cracking observed in both the face and top of cap.
  - Longitudinal cracking in the face and top of the cap indicates the rebars inside the concrete are starting to rust from salt intrusion.
- Cap is visibly tilted back landward throughout majority of wall.
- Previous repairs evident in the cap.
- Spalling of the bottom front face of the cap was observed.

Photo #5- View of Cracking in Top of Cap.

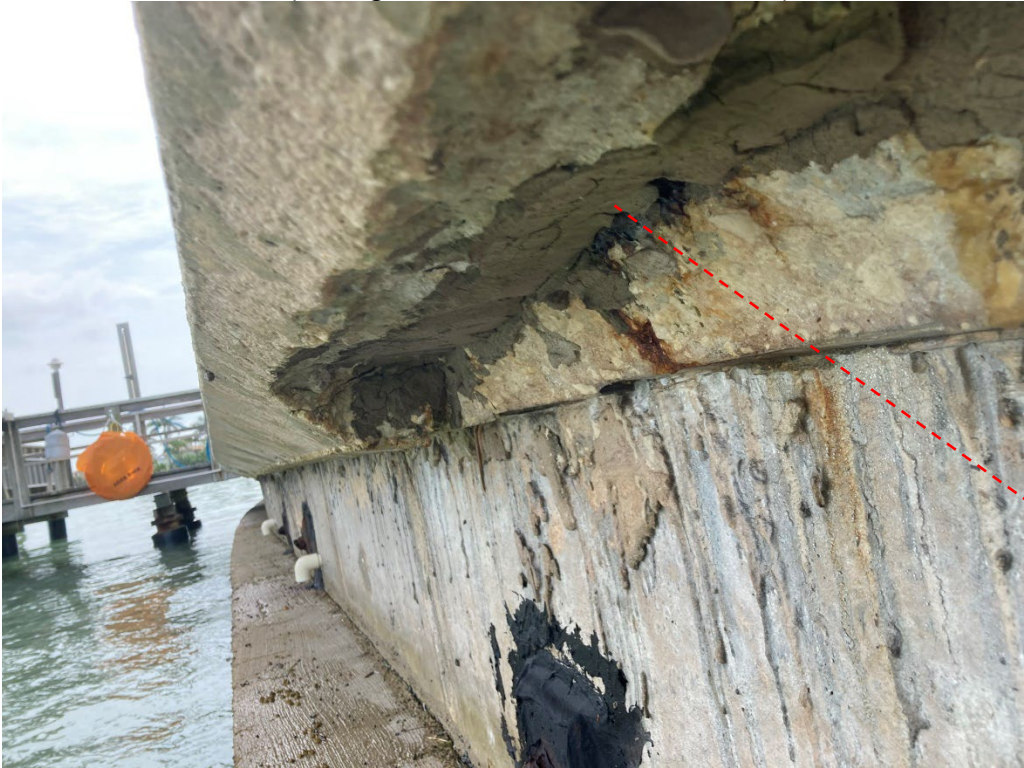
Photo #6- View of Spalling of Bottom Front Face of Cap.

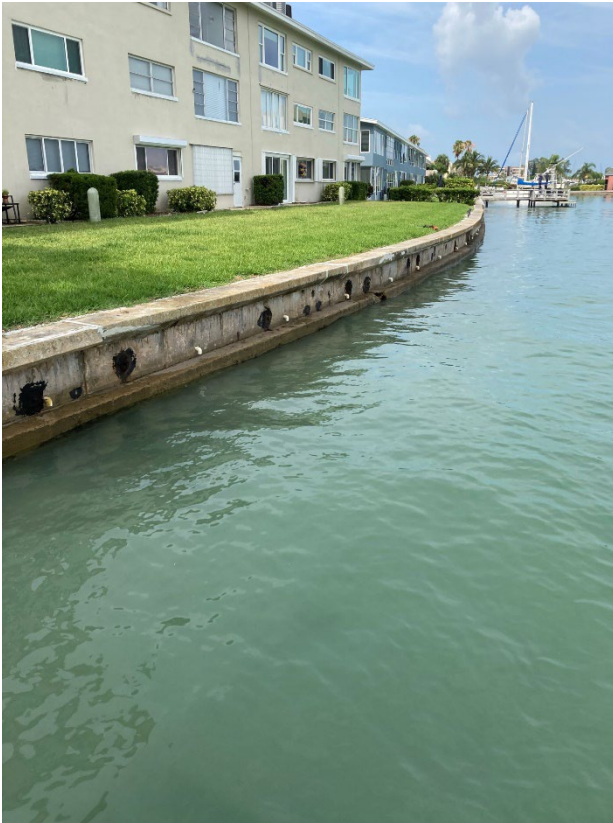
Photo #7- View of Face of Seawall.

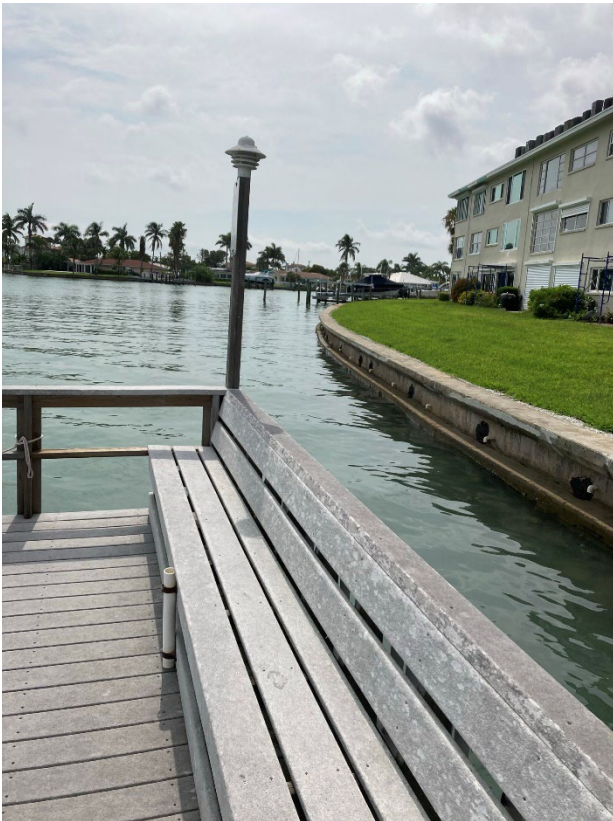
Photo #8- View of Face of Seawall.

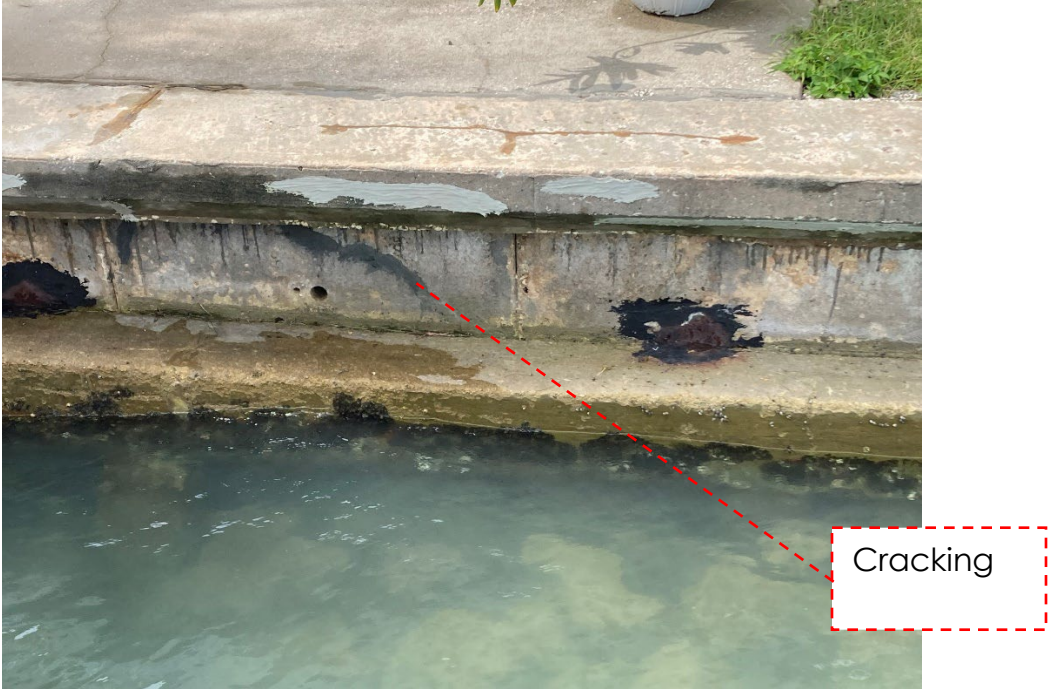
- The vertical slab penetration is currently 20%.
  - The slabs have less than the engineering design standard of 40% penetration in the sediment.
- Structural defects (horizontal/diagonal cracking) were observed in the vertical slabs during the inspection.

Photo #9- View of Cracking in Vertical Slab.

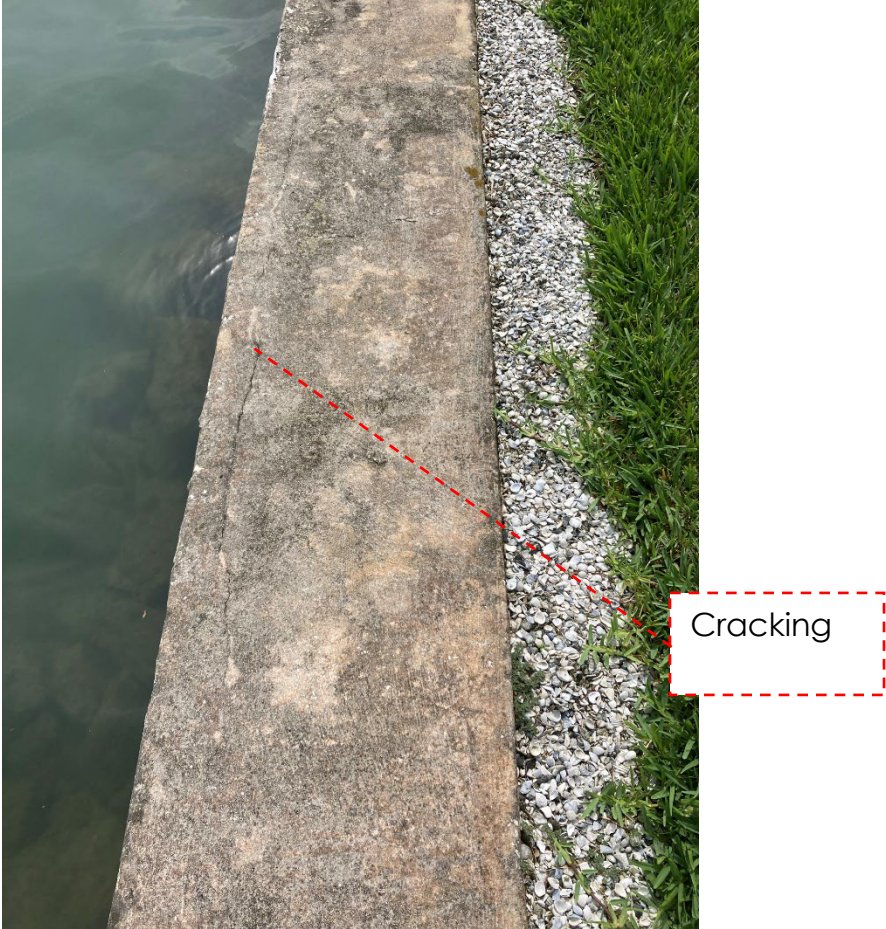
Photo #10- View of Cracking in Top of Cap.
